MIDDLEBURY STATE AIRPORT PHOTOS

MORRISVILLE – STOWE STATE AIRPORT PHOTOS

NEWPORT STATE AIRPORT PHOTOS

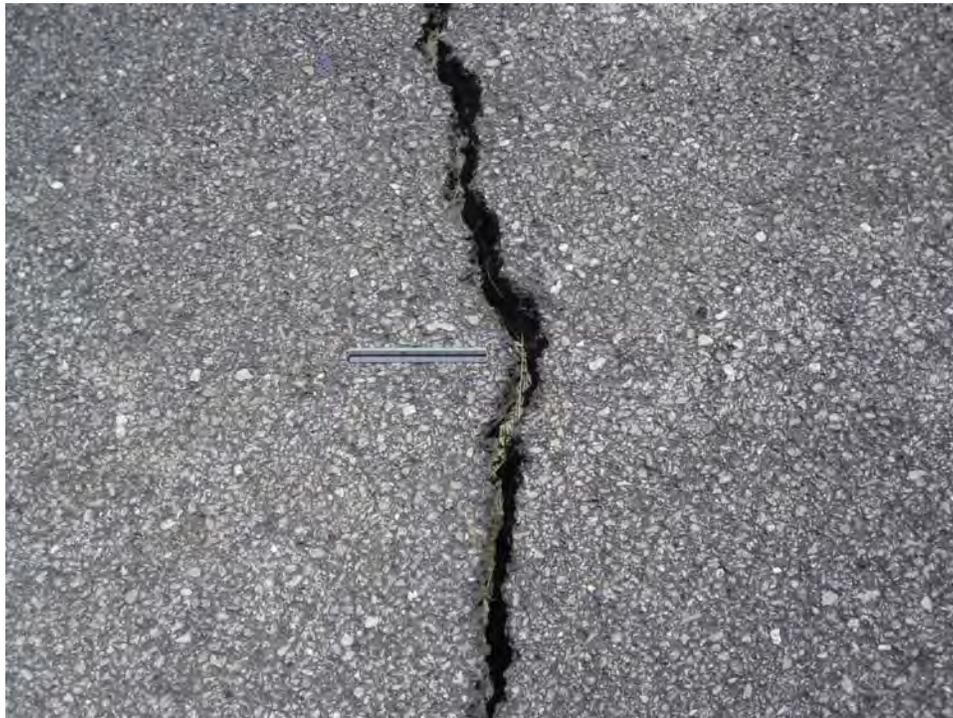
A01SP-20. Longitudinal and transverse cracking (1).

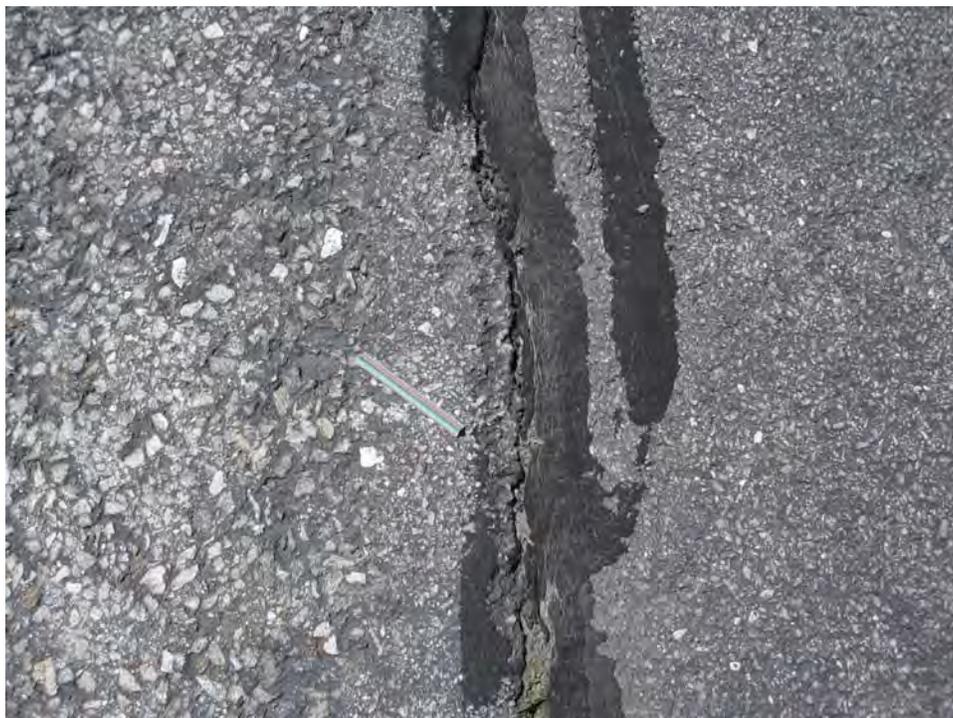
A01SP-20. Longitudinal and transverse cracking (2).

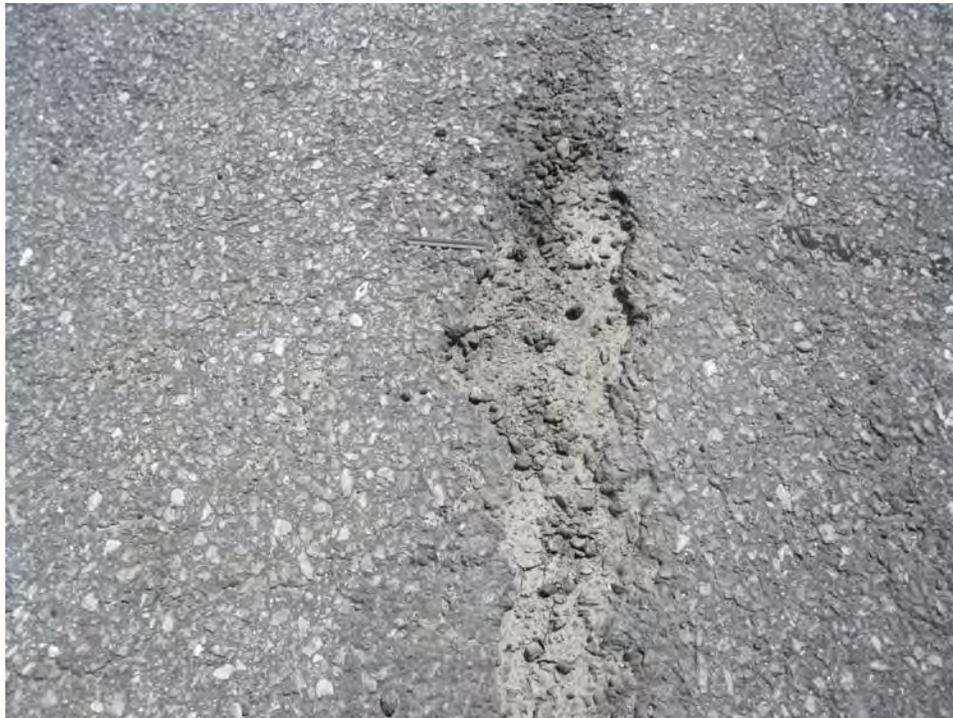
A01SP-20. Raveling.

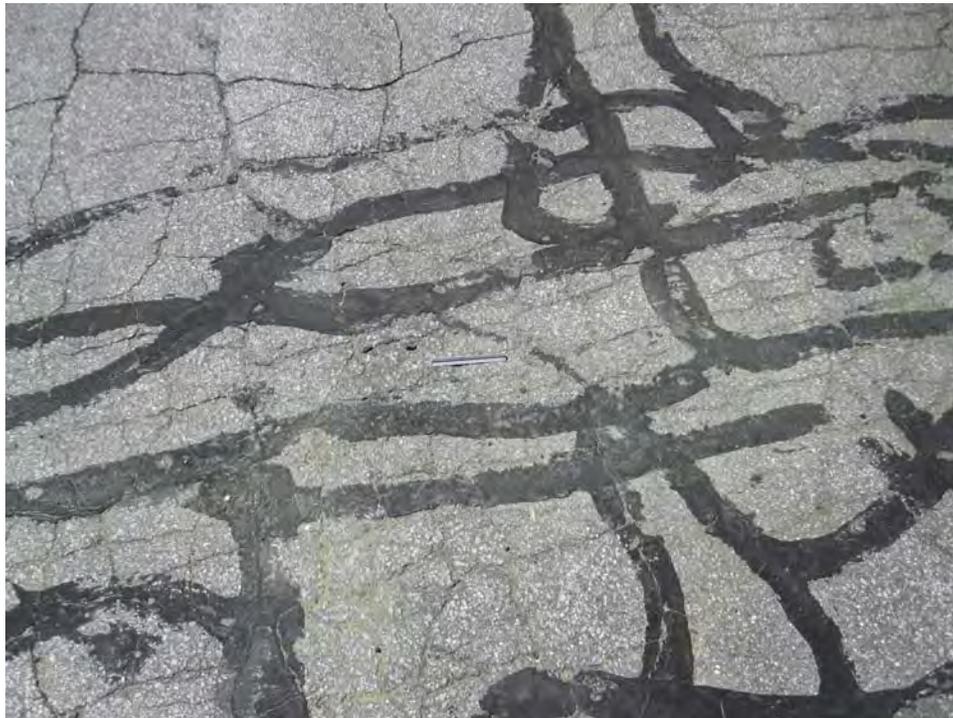
A01SP-30. Alligator cracking.

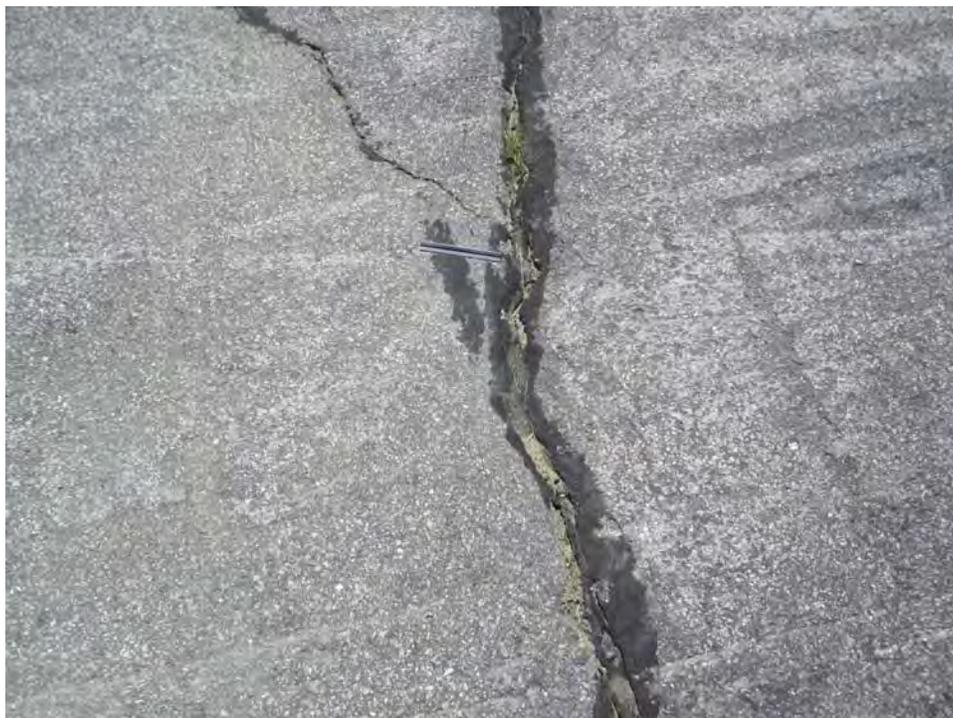
A01SP-30. Longitudinal and transverse cracking.

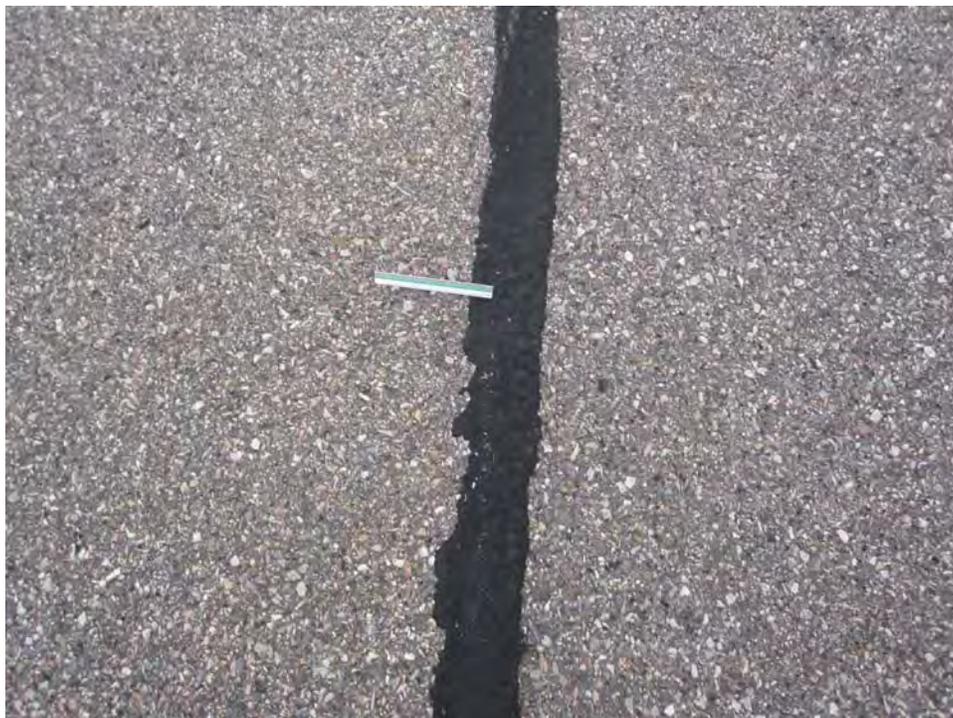
RW119MB-10. Longitudinal and transverse cracking.

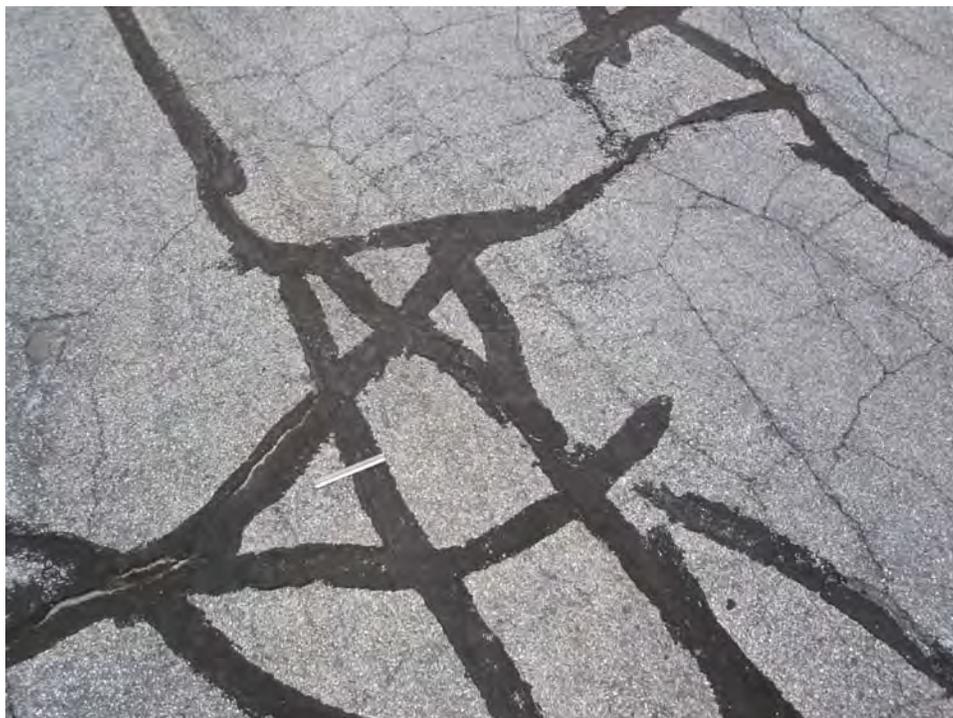
TW01MB-10. Alligator cracking.

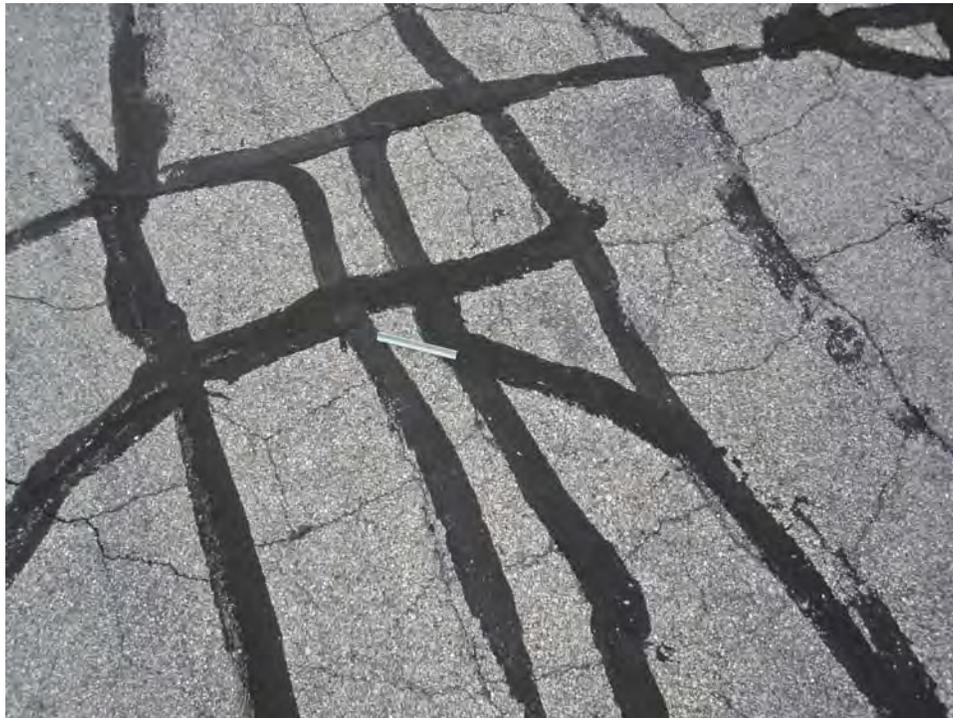
TW01MB-30. Alligator cracking.

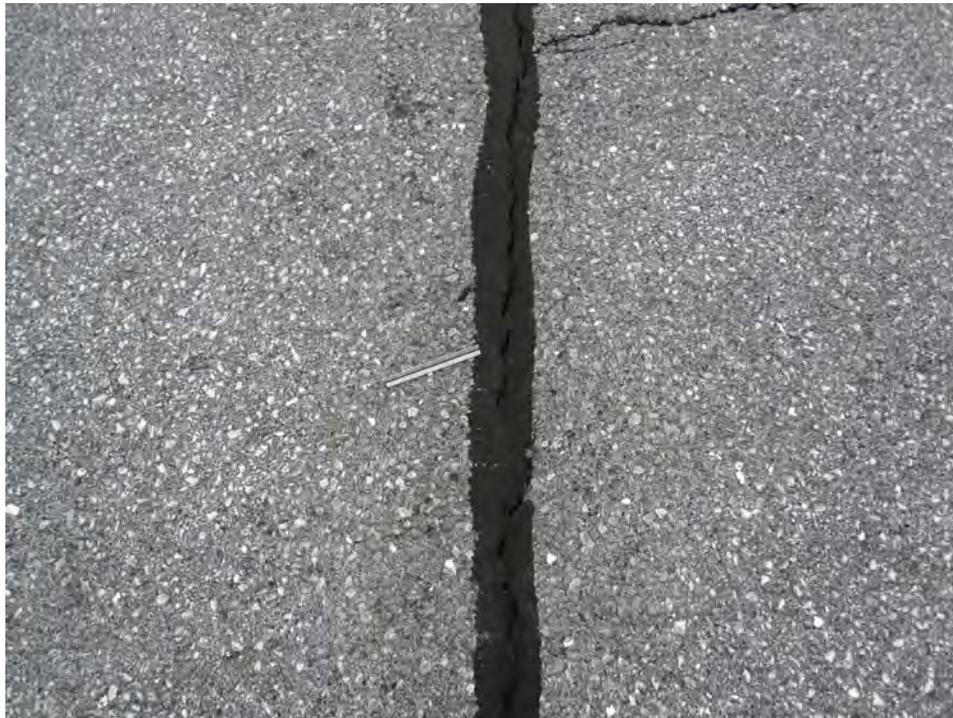
TW01MB-40. Longitudinal and transverse cracking.

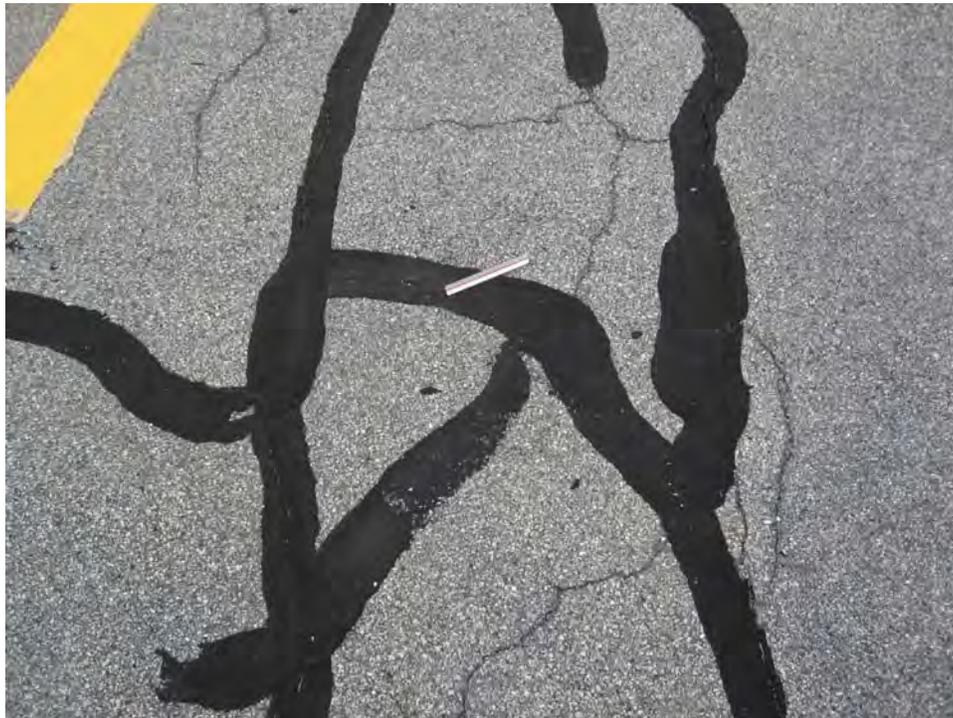
TW01MB-50. Alligator cracking.

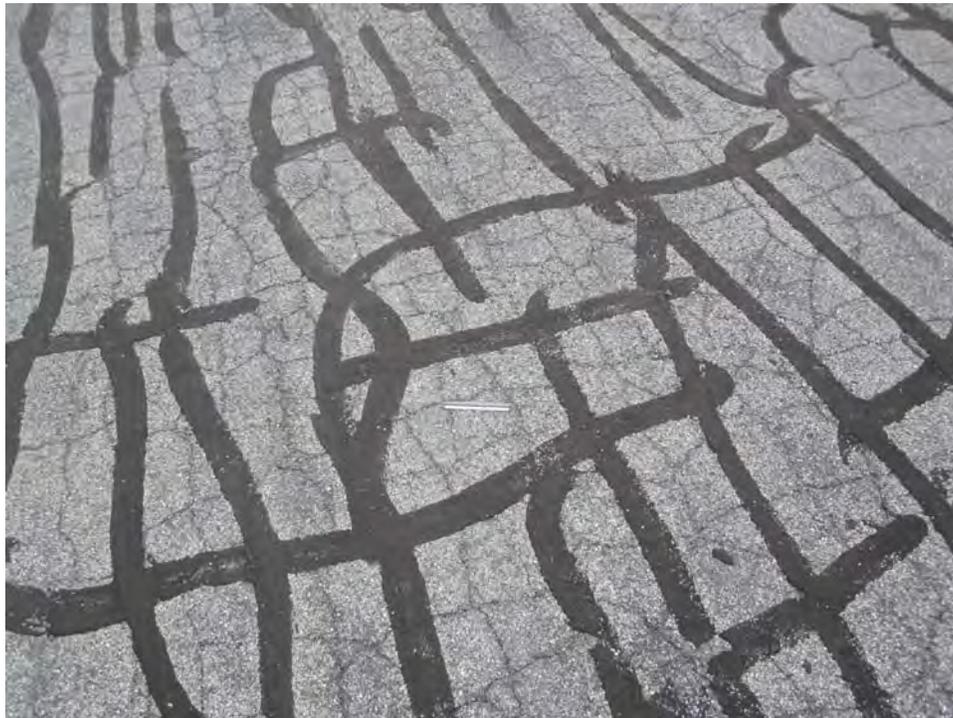
TW01MB-60. Alligator cracking.

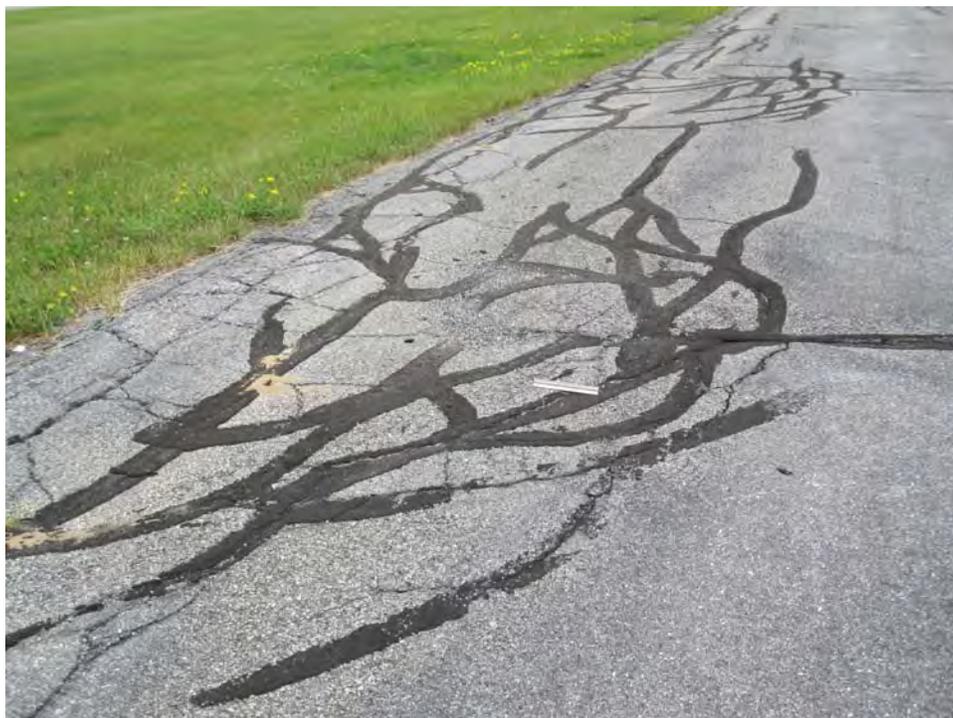
TW01MB-60. Rutting and alligator cracking.

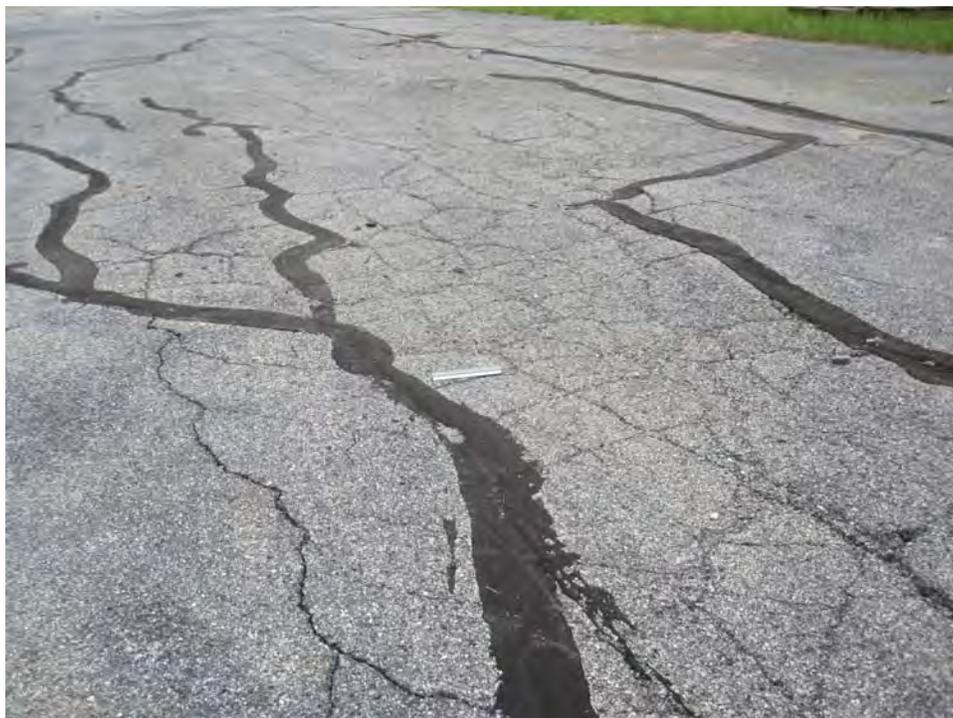
TW01MB-70. Rutting and alligator cracking.

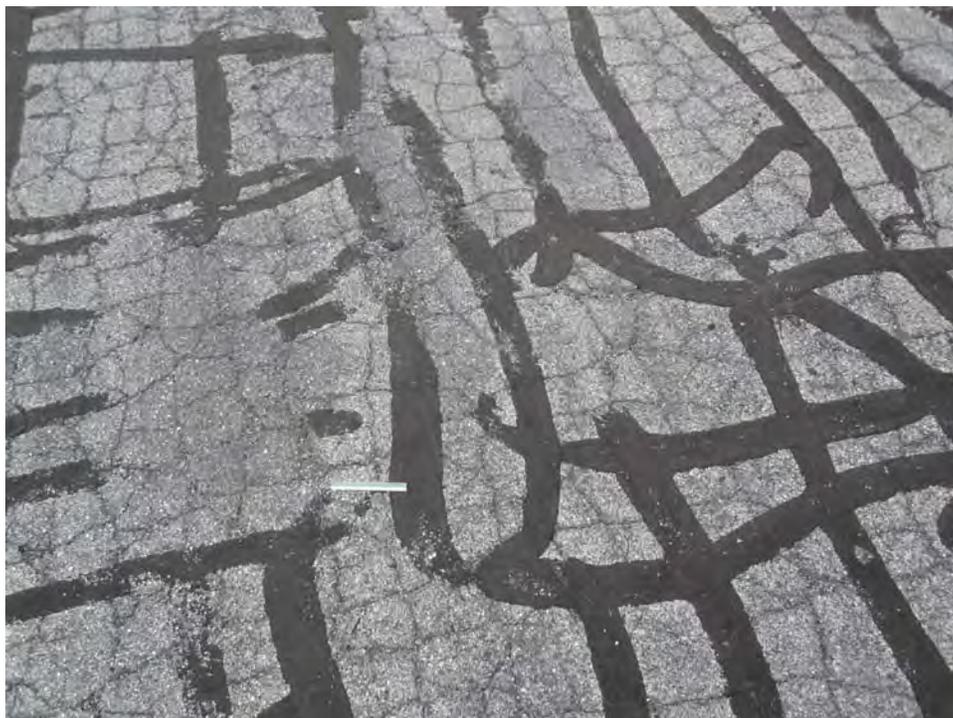
TW01MB-80. Alligator cracking.

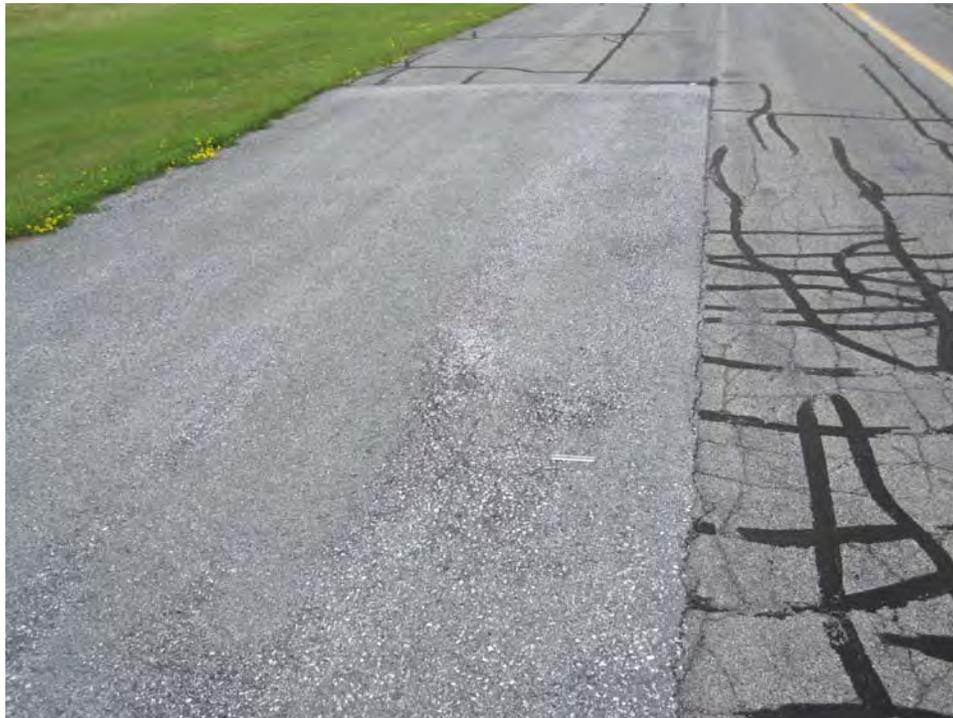
TW01MB-80. Patching.

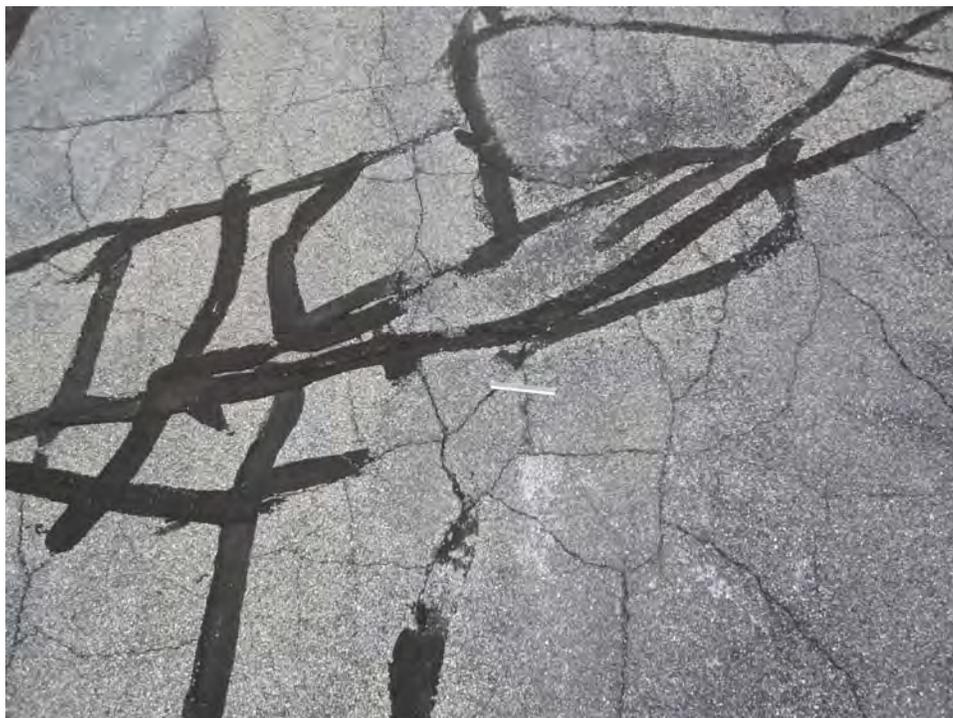
A01MB-10. Alligator cracking.

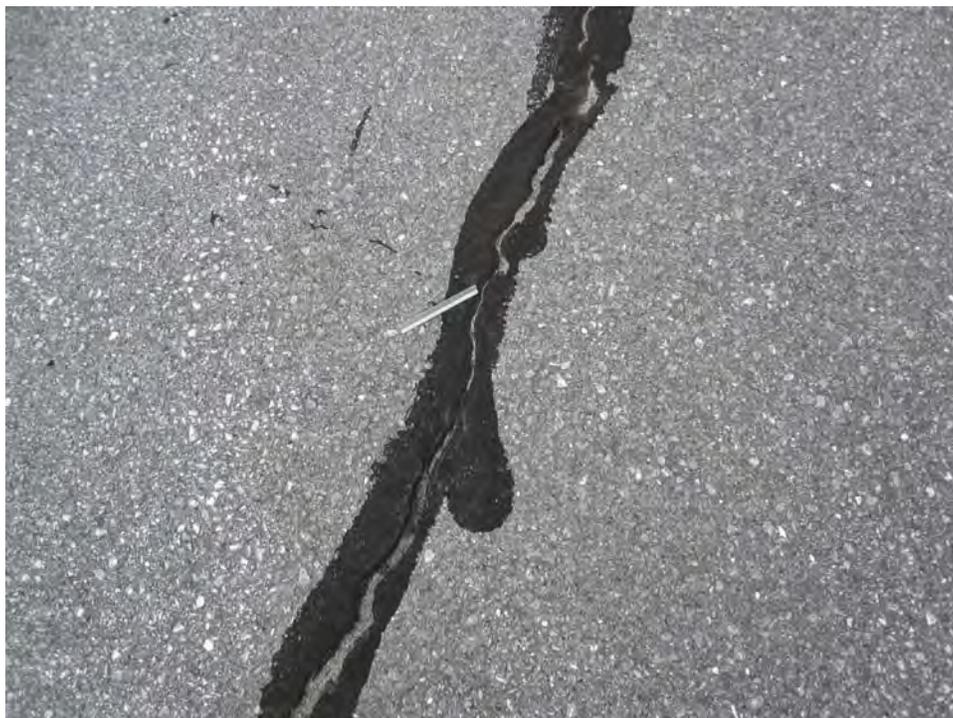
A02MB-10. Longitudinal and transverse cracking.

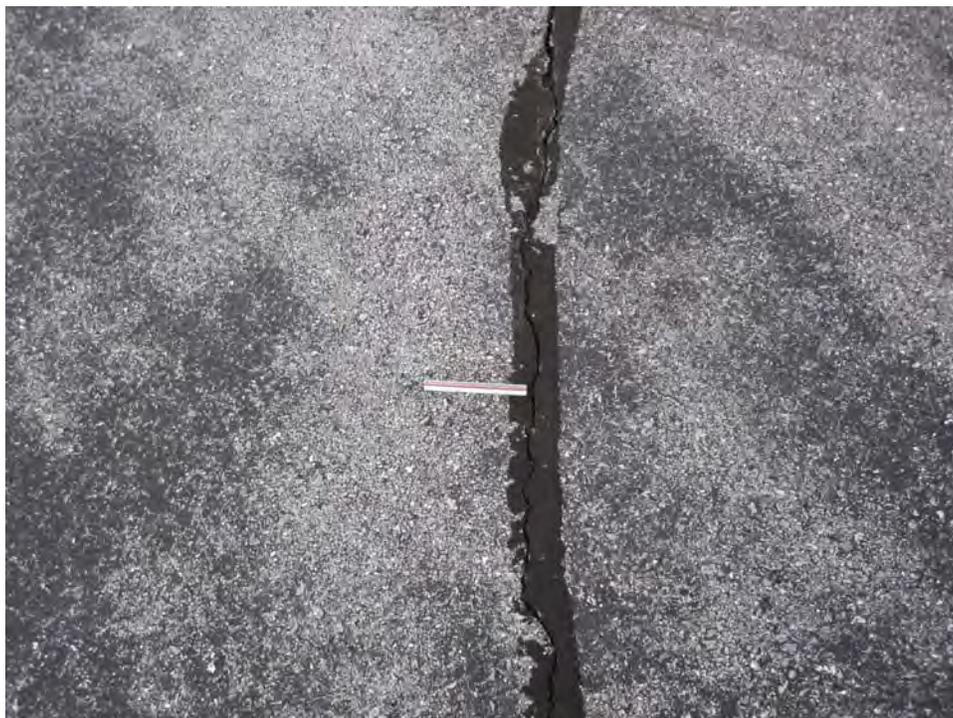
A03MB-10. Longitudinal and transverse cracking.

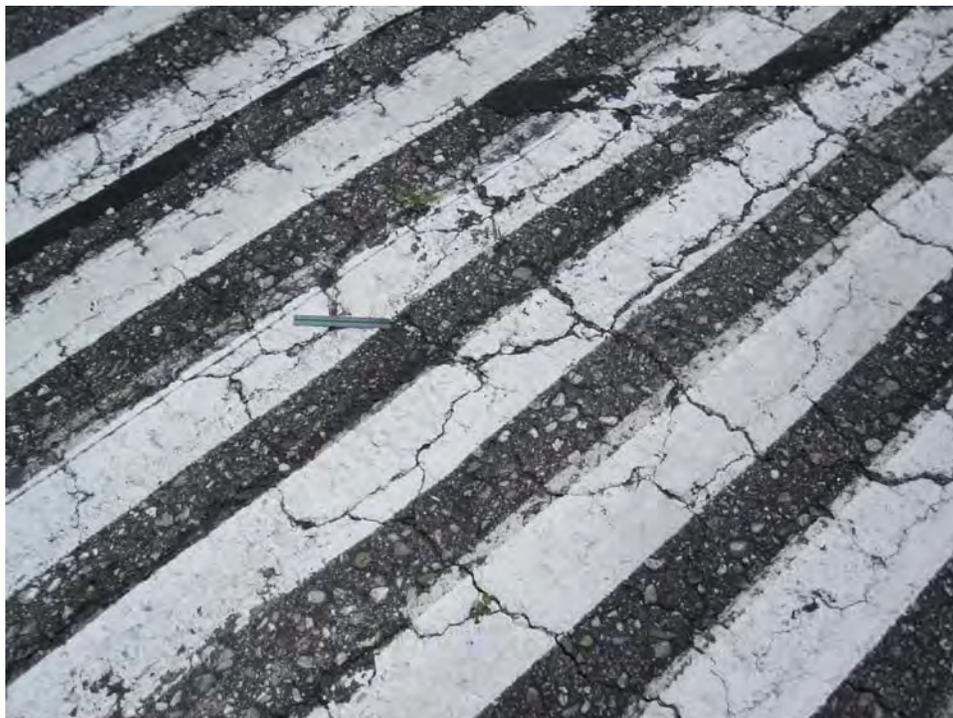
RW119MV-10. Alligator cracking.

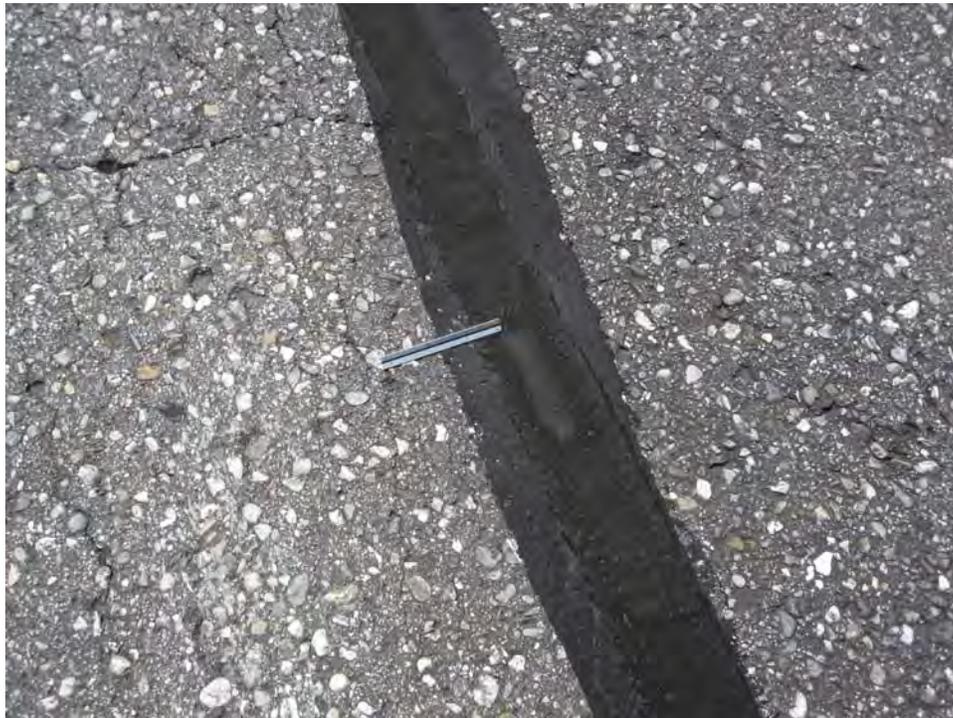
RW119MV-10. Longitudinal and transverse cracking.

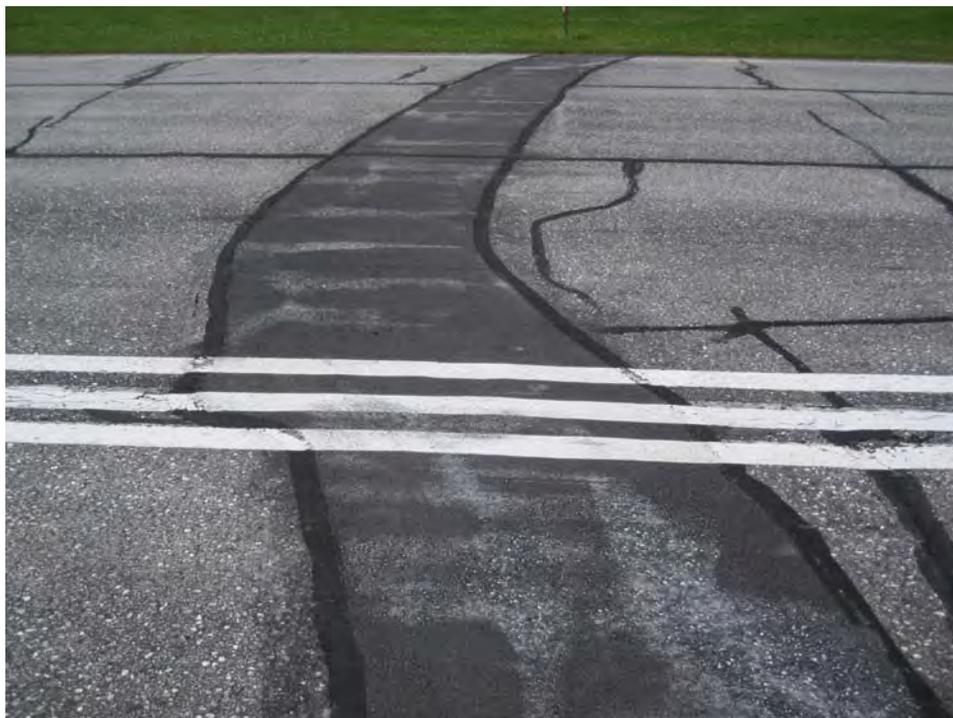
RW119MV-10. Patching (1).

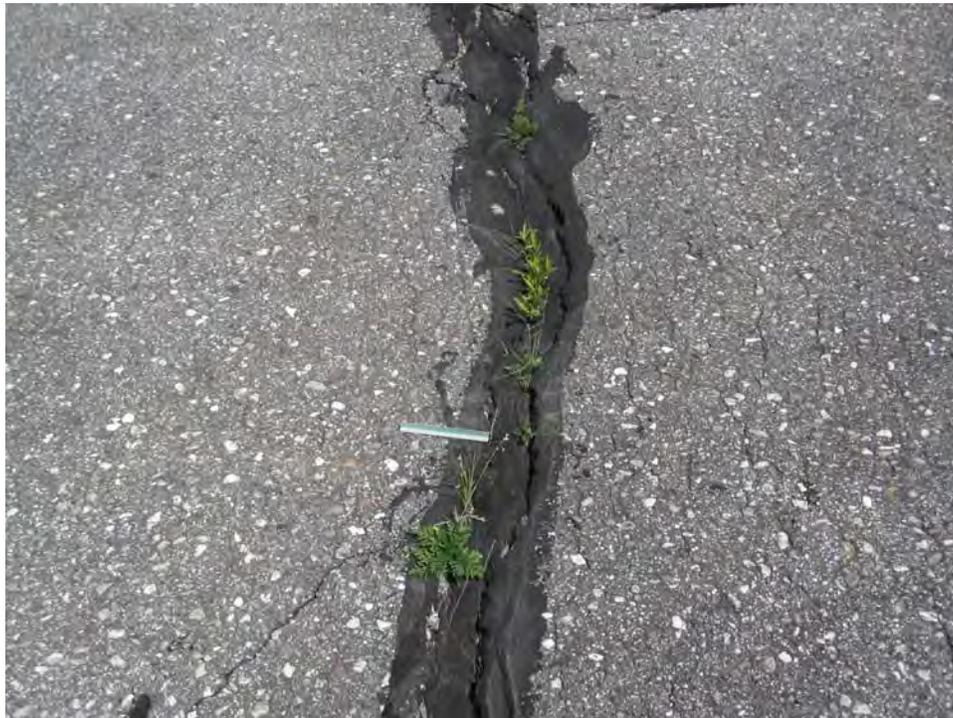
RW119MV-20. Longitudinal and transverse cracking (1).

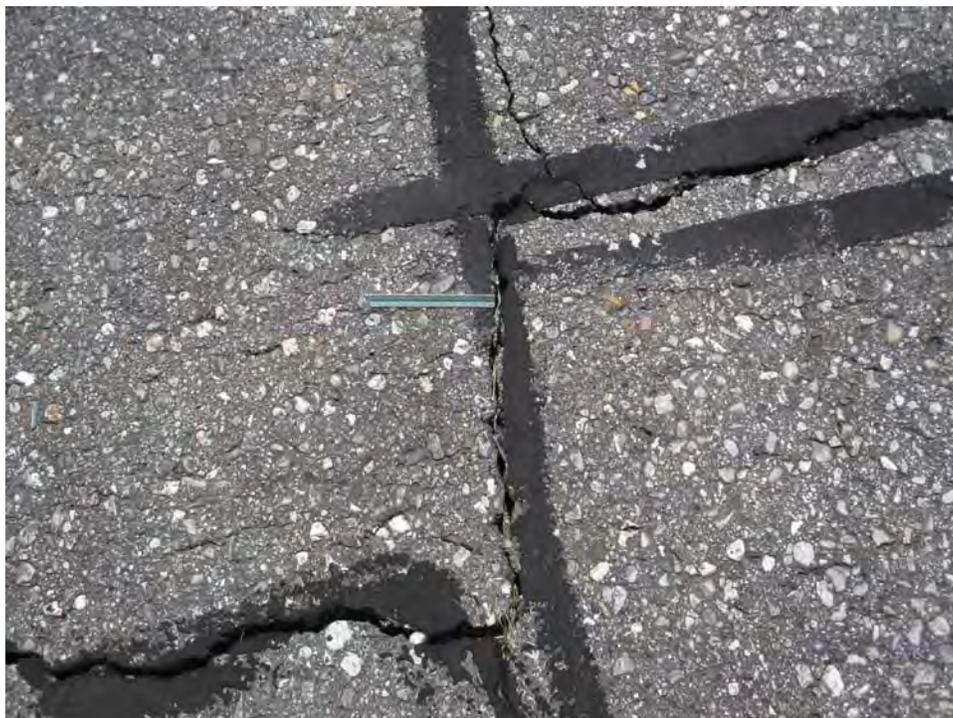
RW119MV-20. Longitudinal and transverse cracking (2).

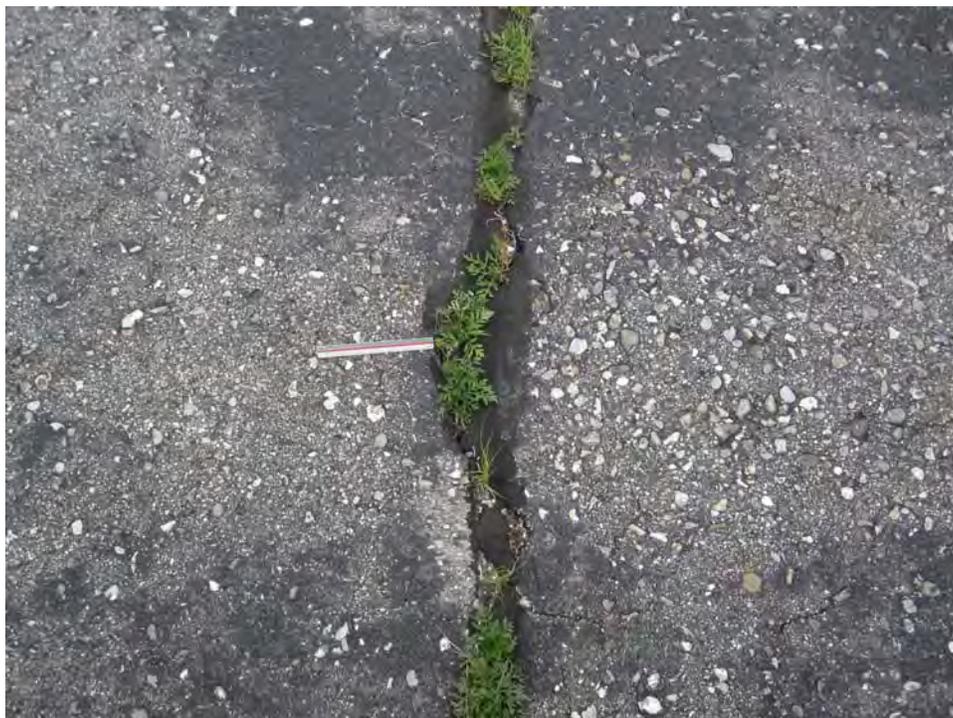
TWBMV-10. Longitudinal and transverse cracking.

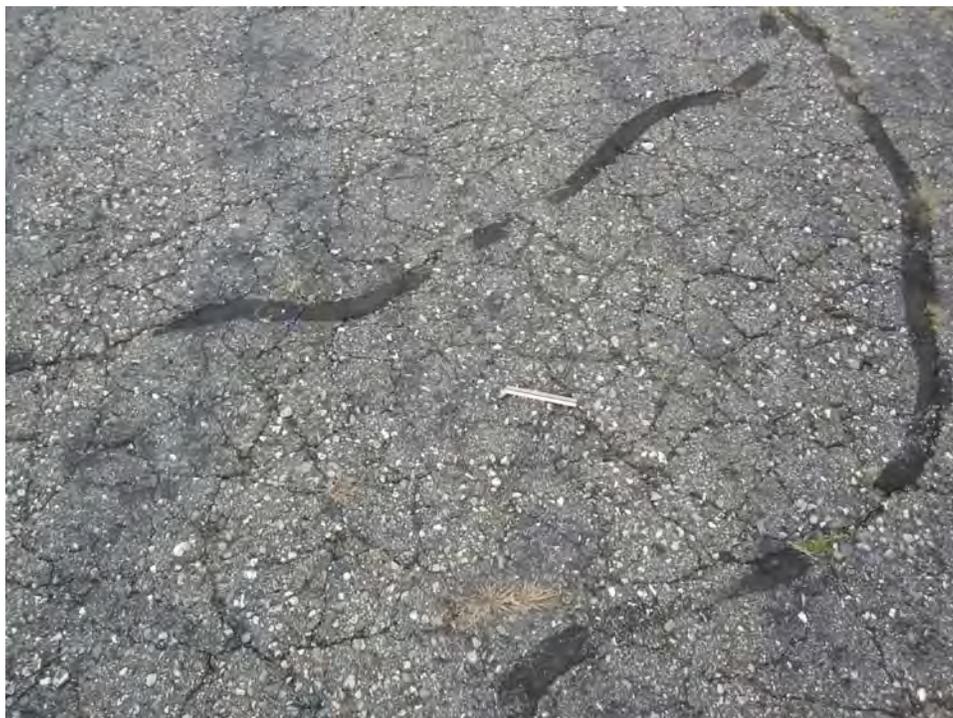
TWCMV-10. Alligator cracking.

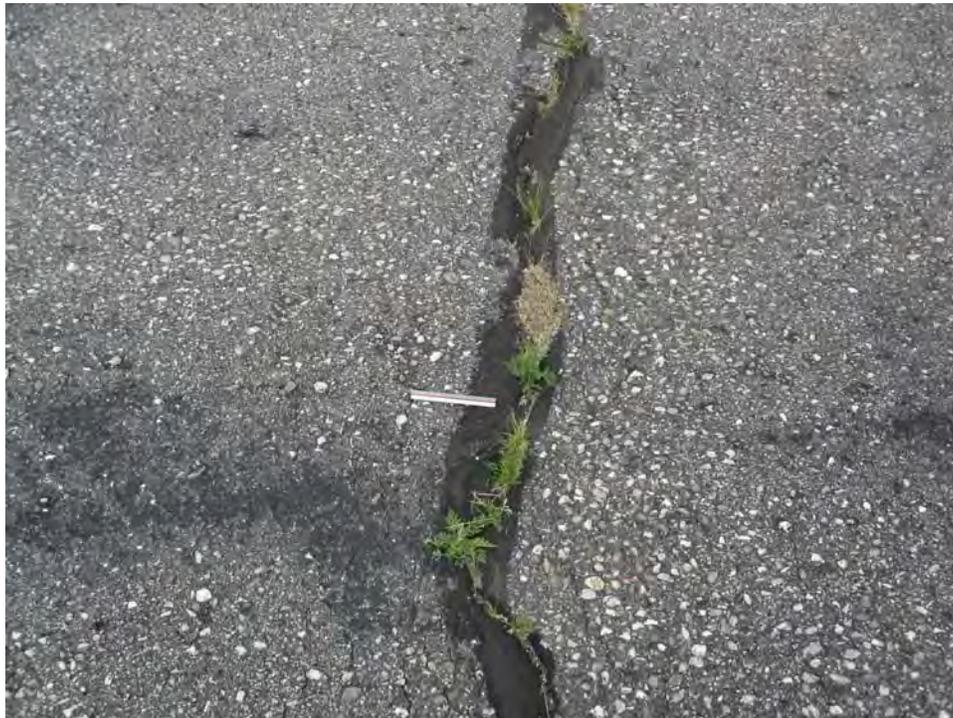
TWCMV-10. Longitudinal and transverse cracking.

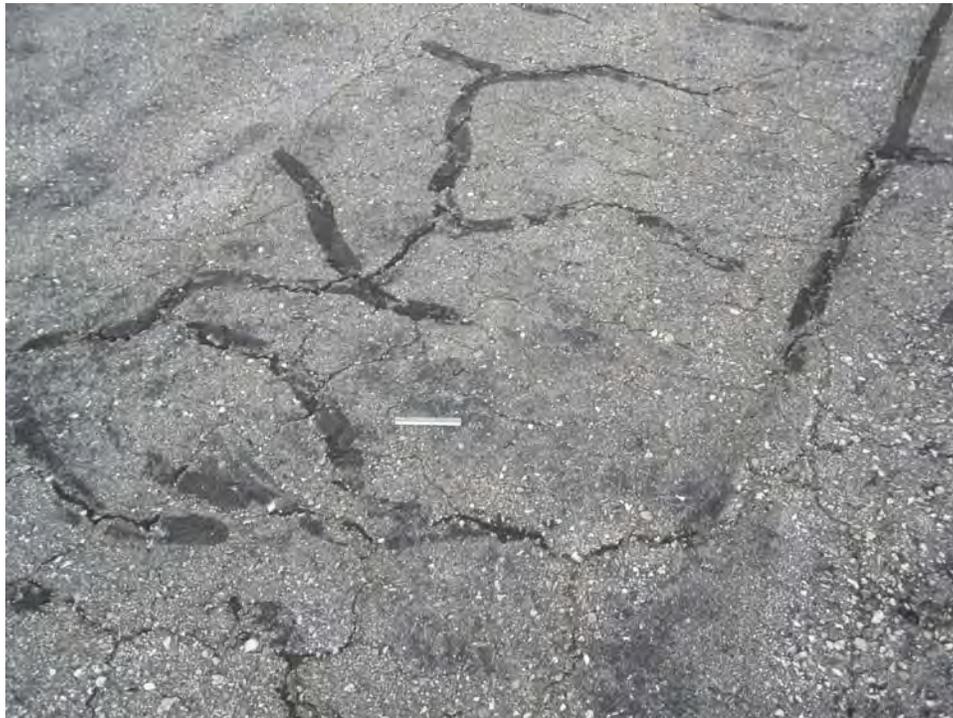
A01MV-10. Block cracking.

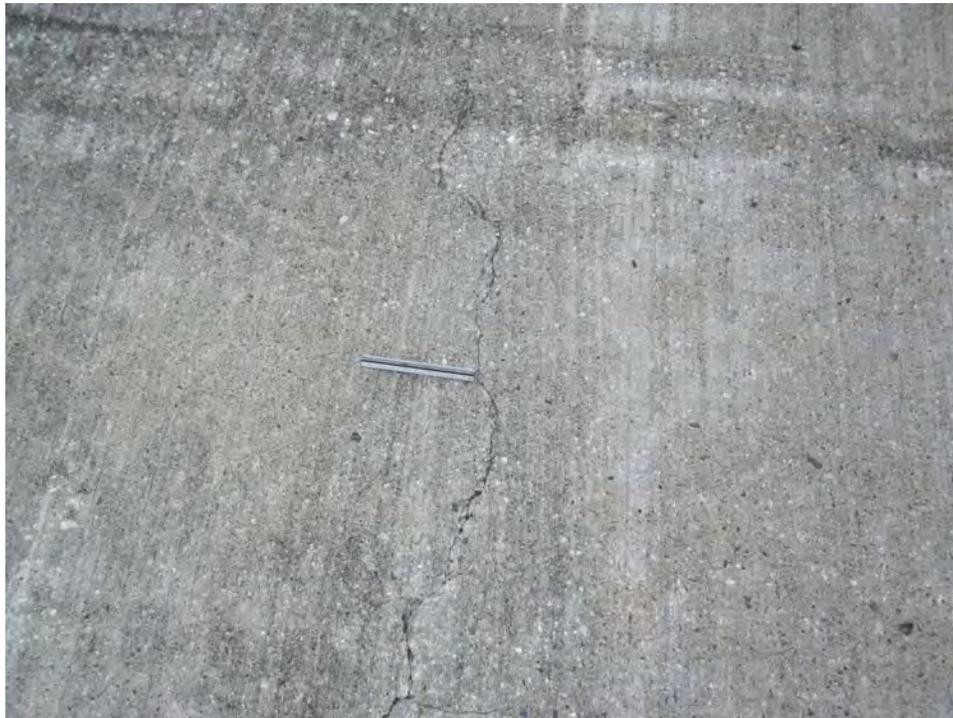
A01MV-20. Longitudinal, transverse and diagonal cracking.

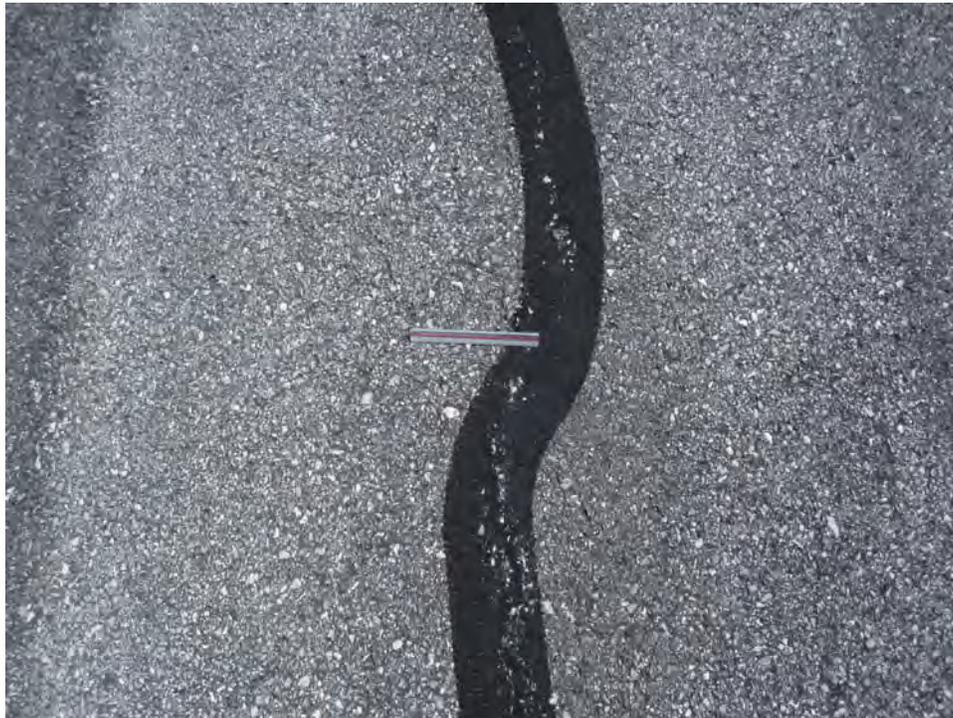
RW1836NP-10. Longitudinal and transverse cracking.

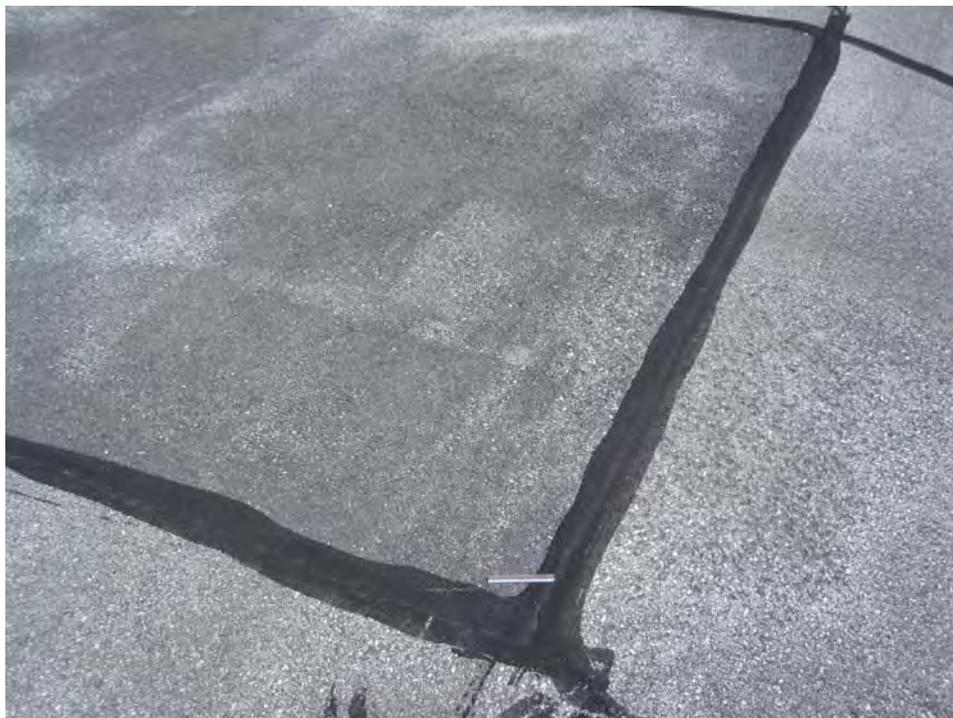
RW1836NP-10. Patching.

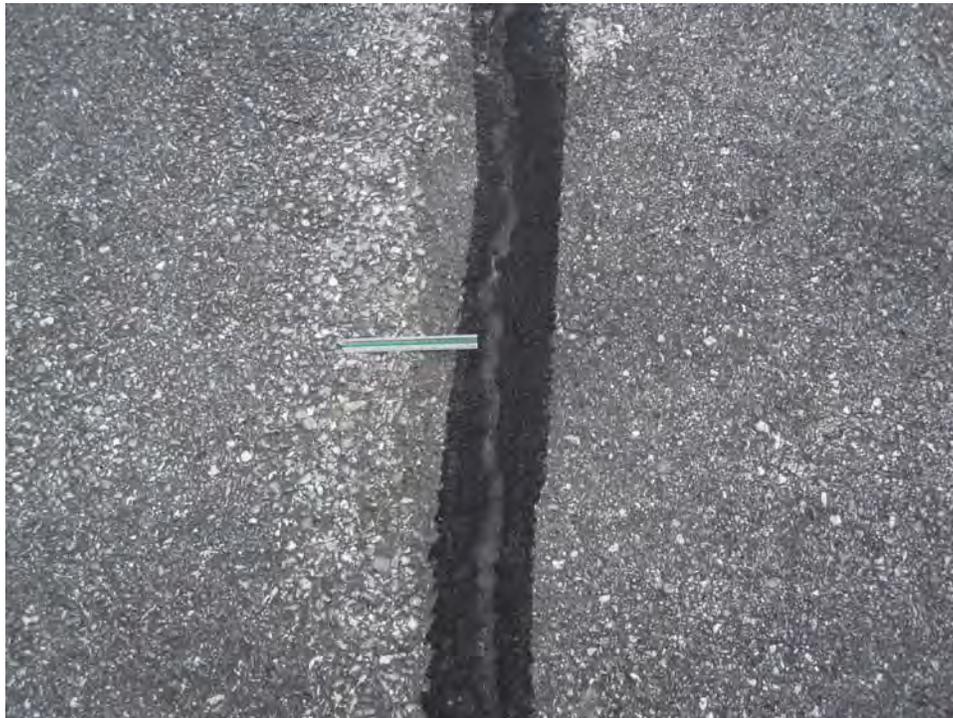
RW1836NP-20. Longitudinal and transverse cracking.

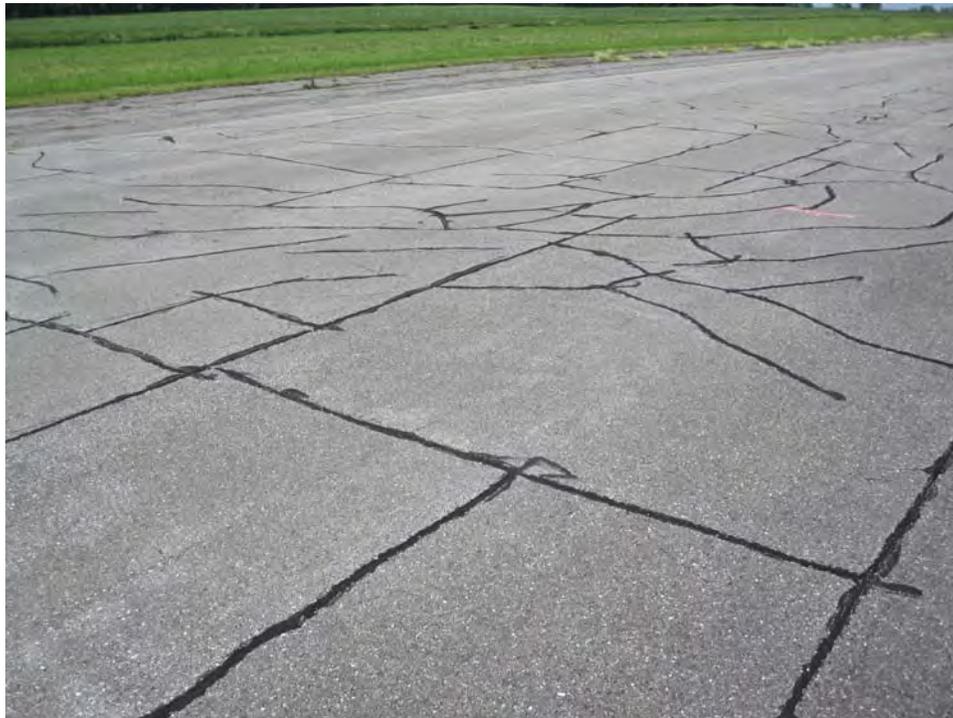
RW523NP-10. Block cracking.

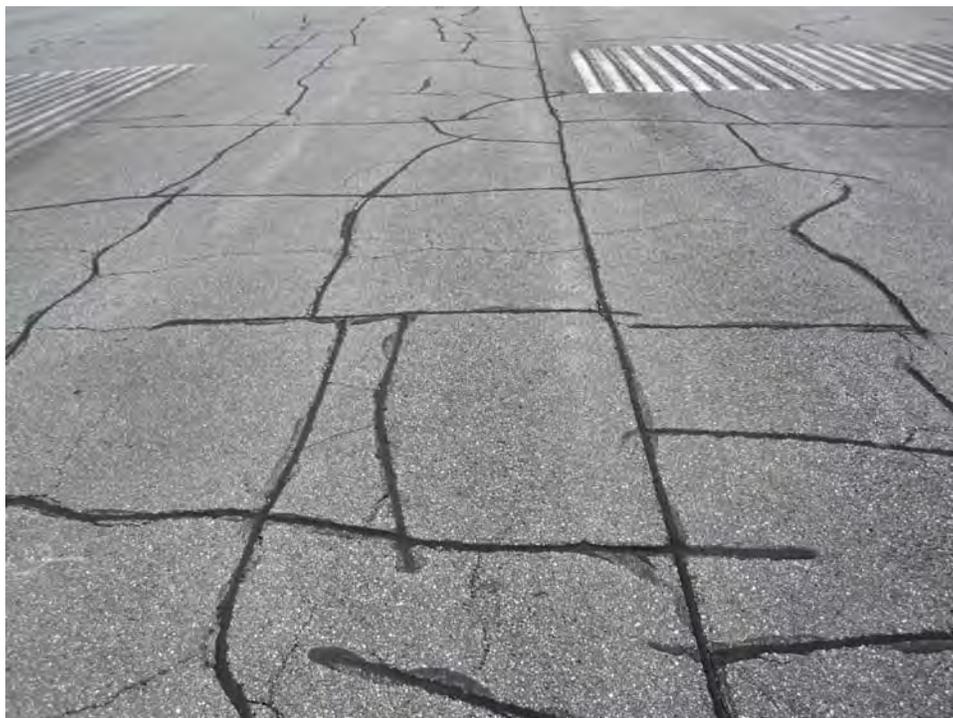
RW523NP-30. Block cracking
