MIDDLEBURY STATE AIRPORT PHOTOS

MORRISVILLE – STOWE STATE AIRPORT PHOTOS

NEWPORT STATE AIRPORT PHOTOS

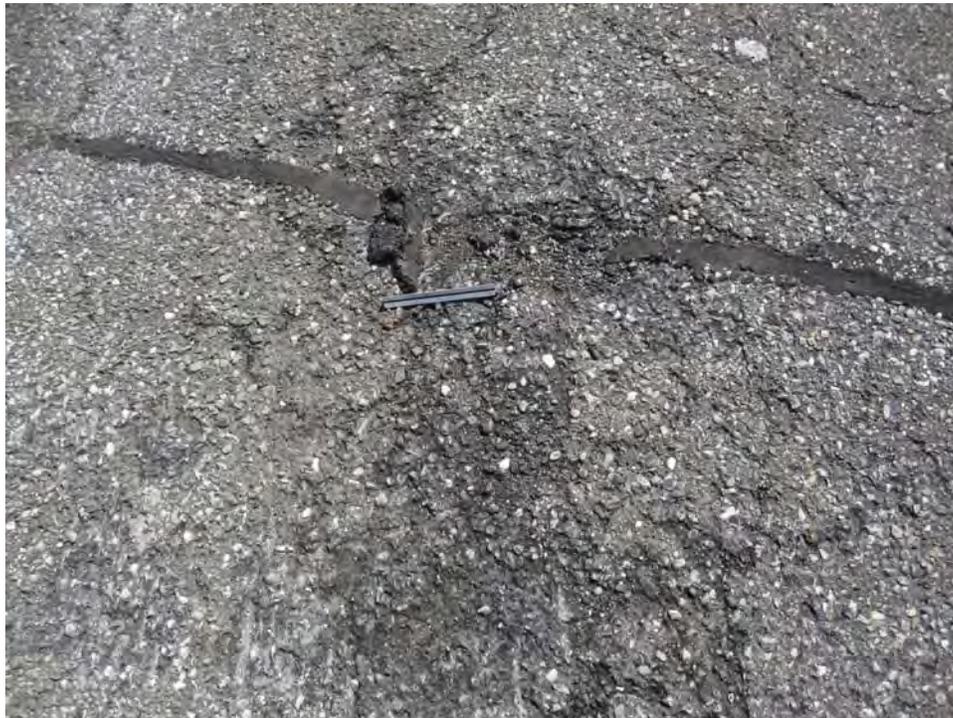
RW523NP-30. Raveling.

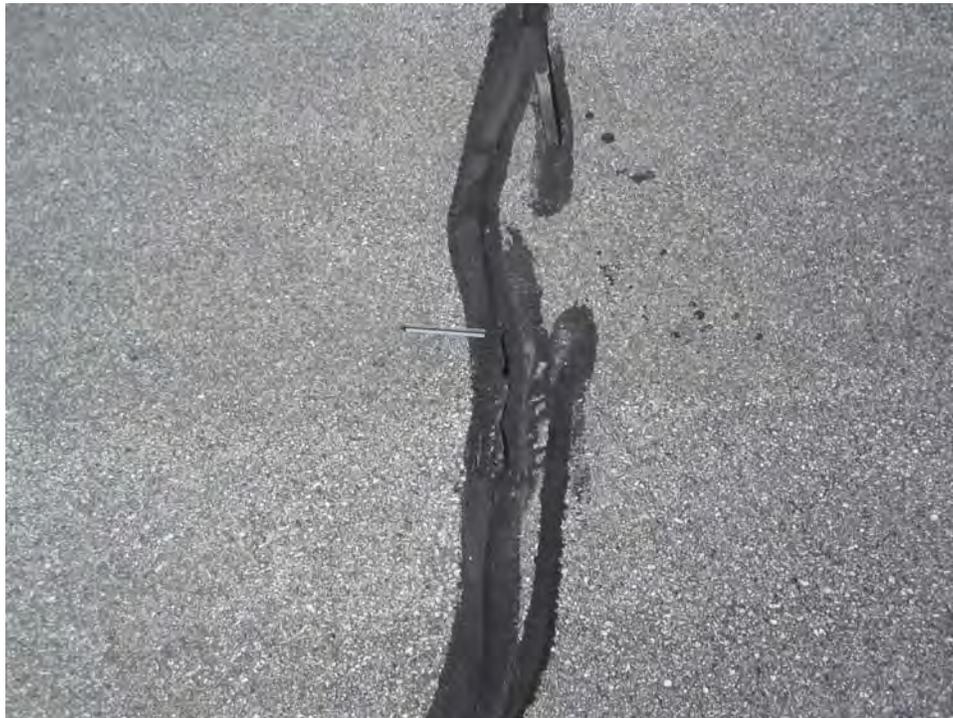
TW01NP-10. Longitudinal and transverse cracking.

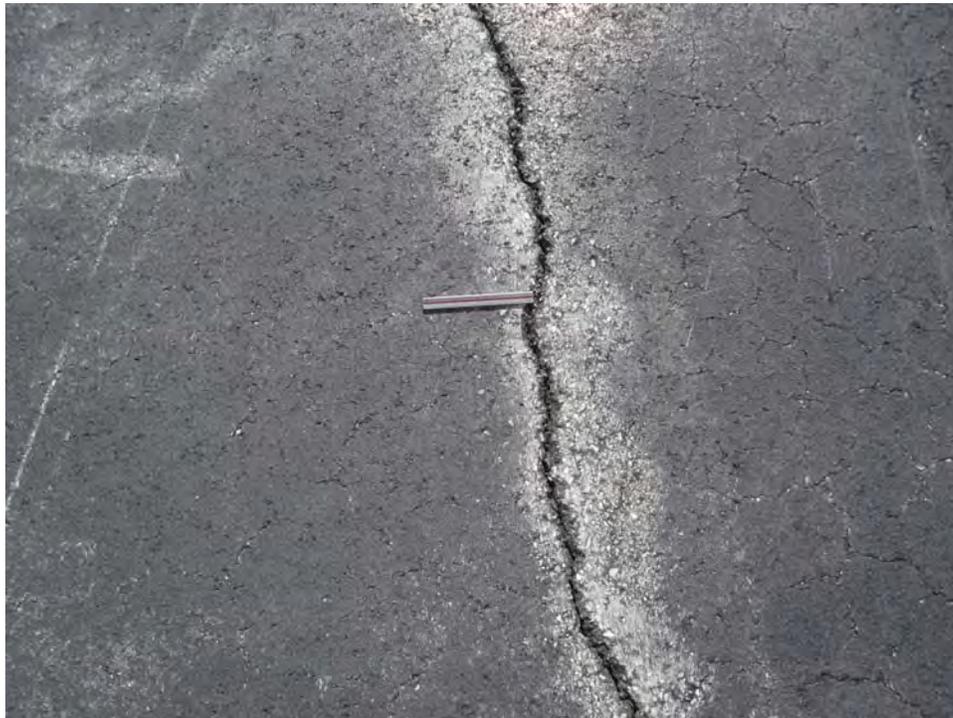
A01NP-10. Longitudinal and transverse cracking.

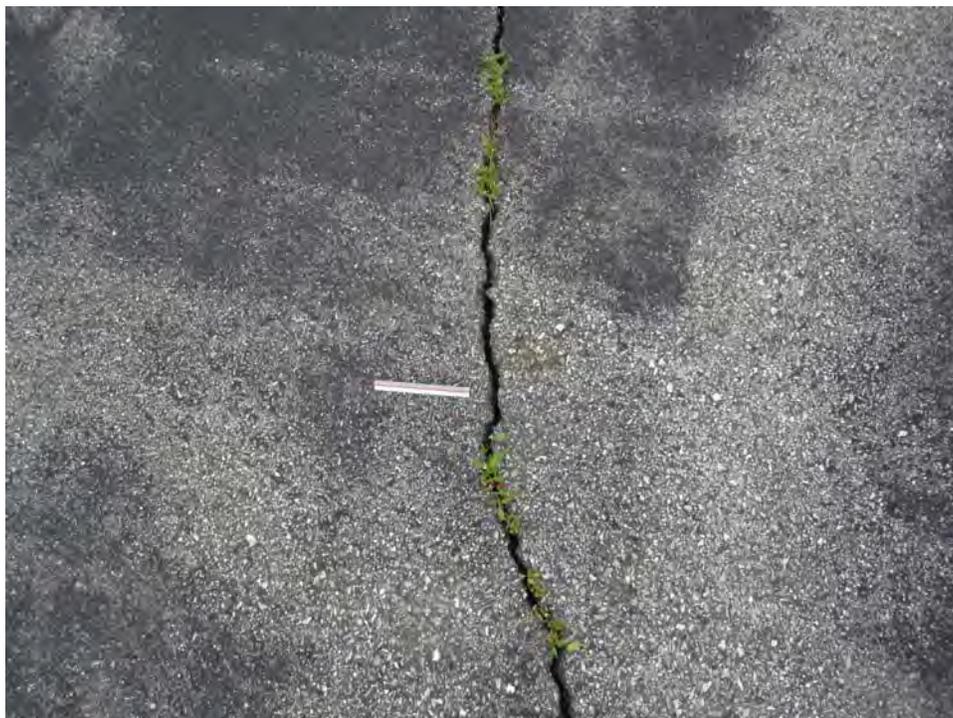
A01NP-40. Longitudinal and transverse cracking.

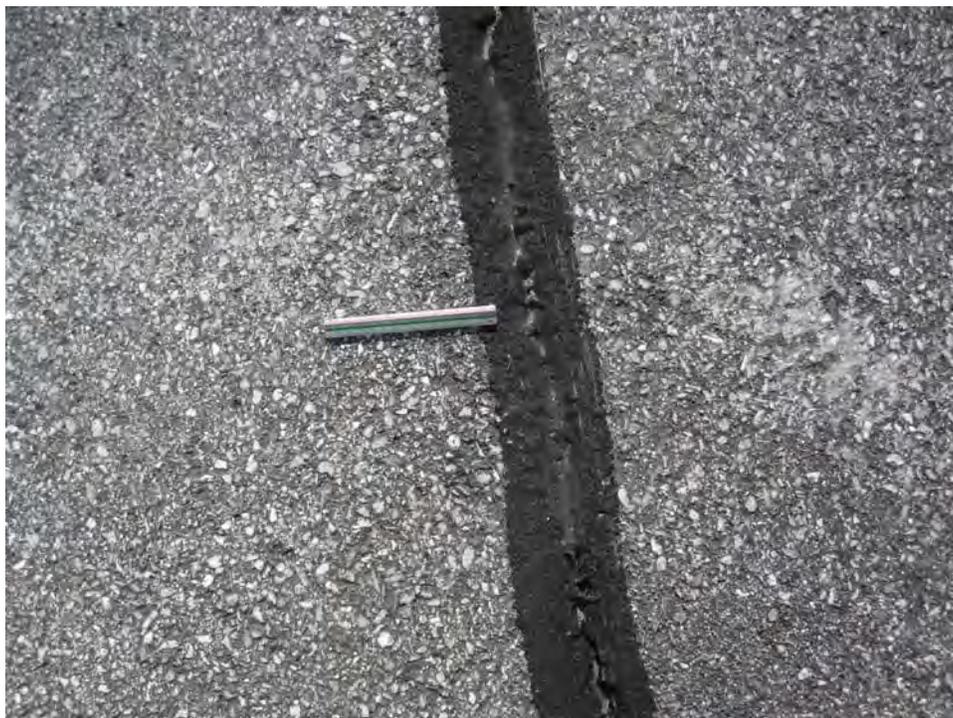
A01NP-60. Longitudinal and transverse cracking.

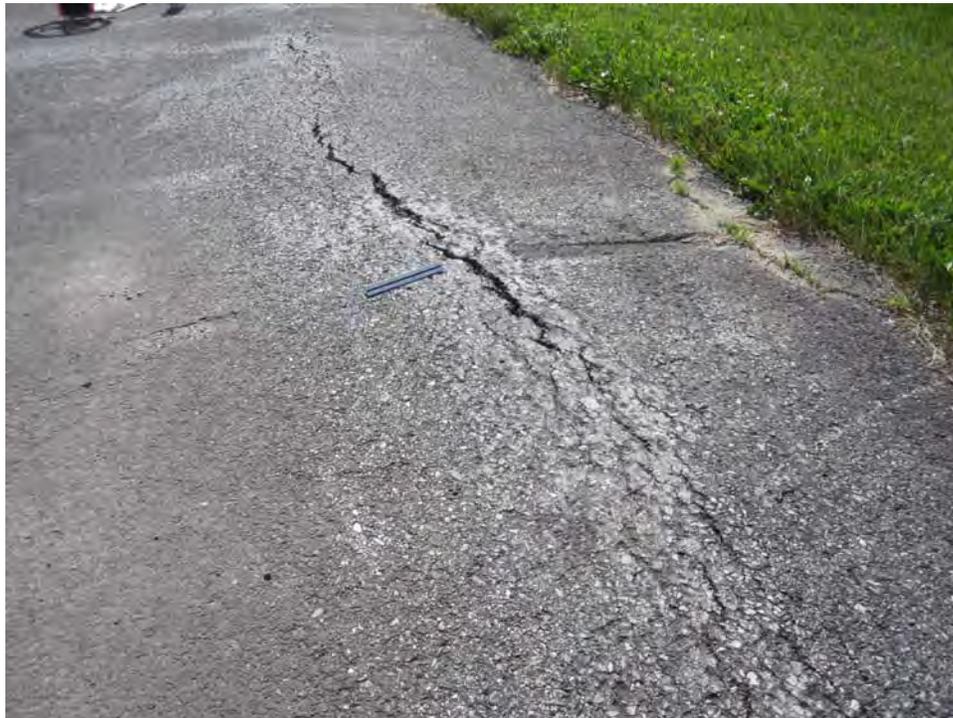
A01NP-60. Swelling.

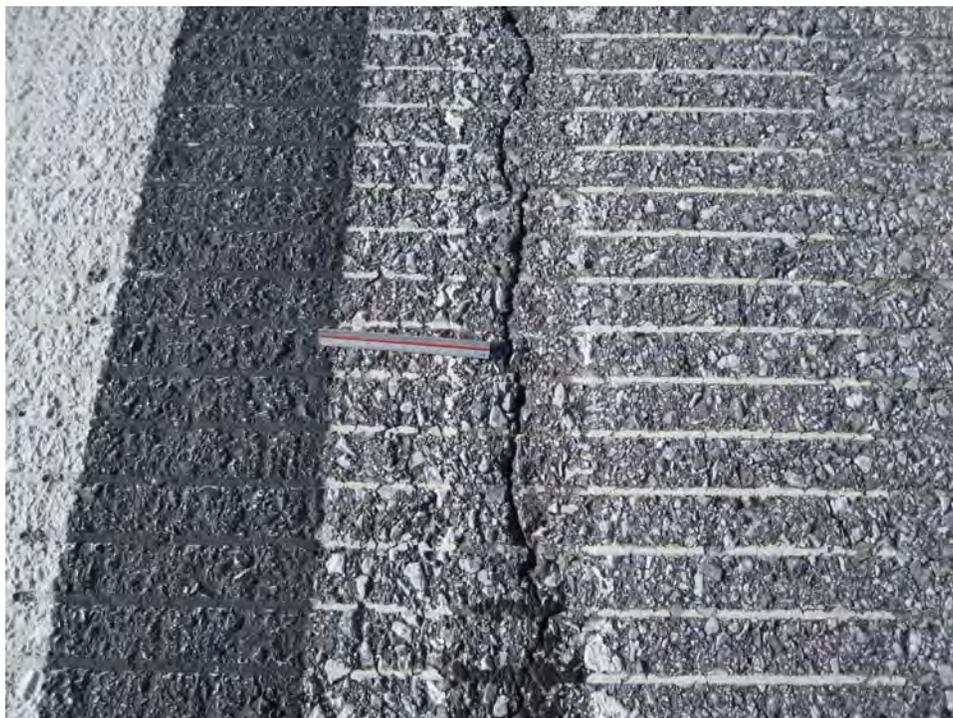
RW119RT-20. Longitudinal cracking and weathering.

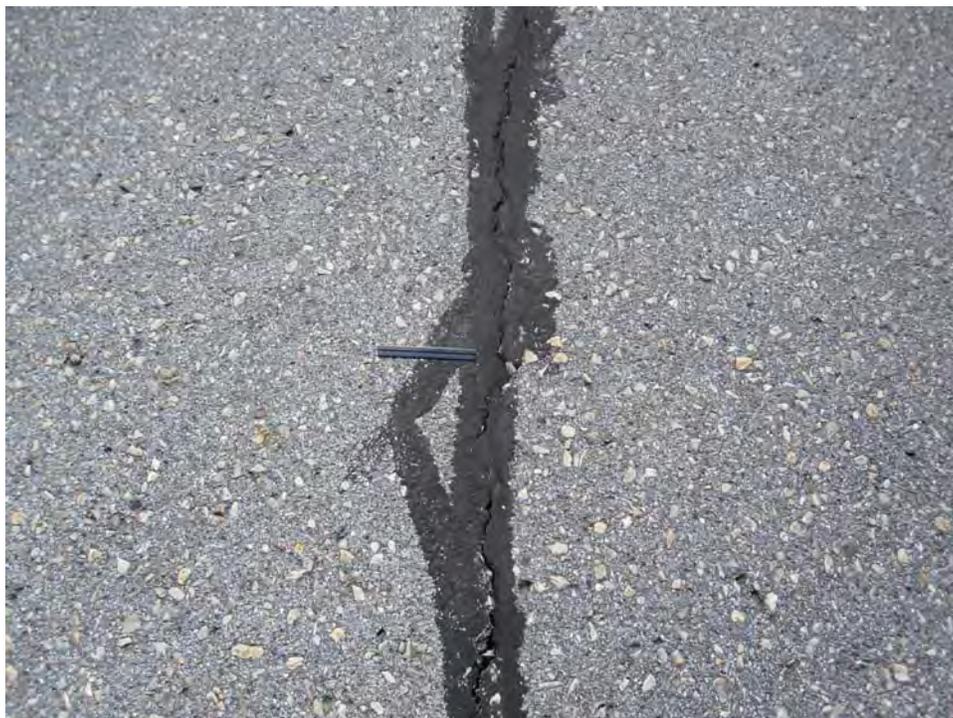
RW1331RT-10. Longitudinal and transverse cracking.

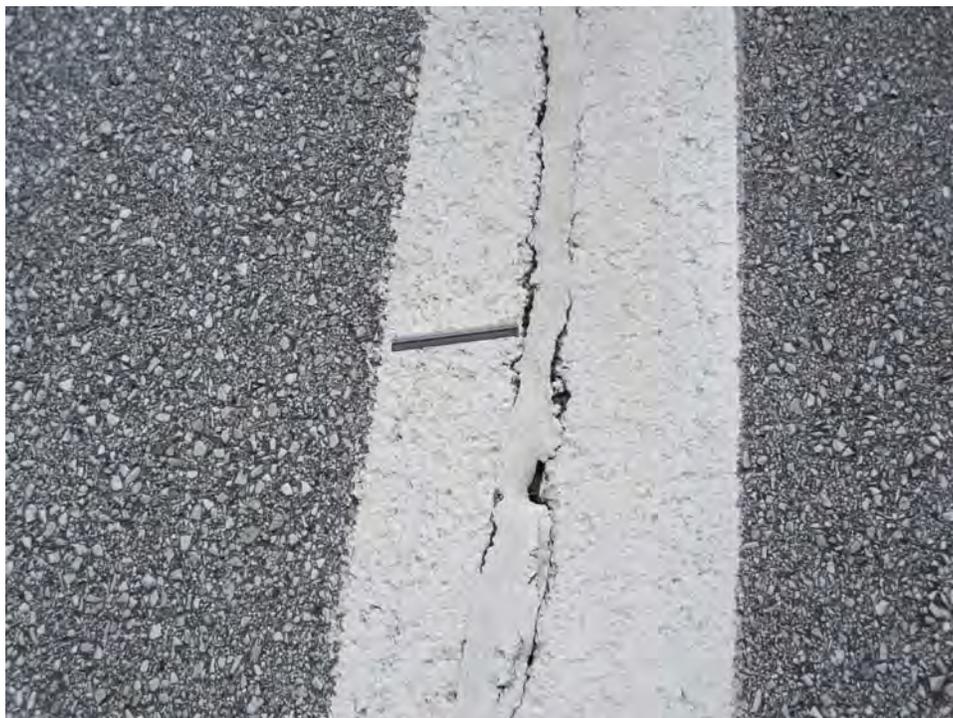
RW1331RT-20. Longitudinal and transverse cracking.

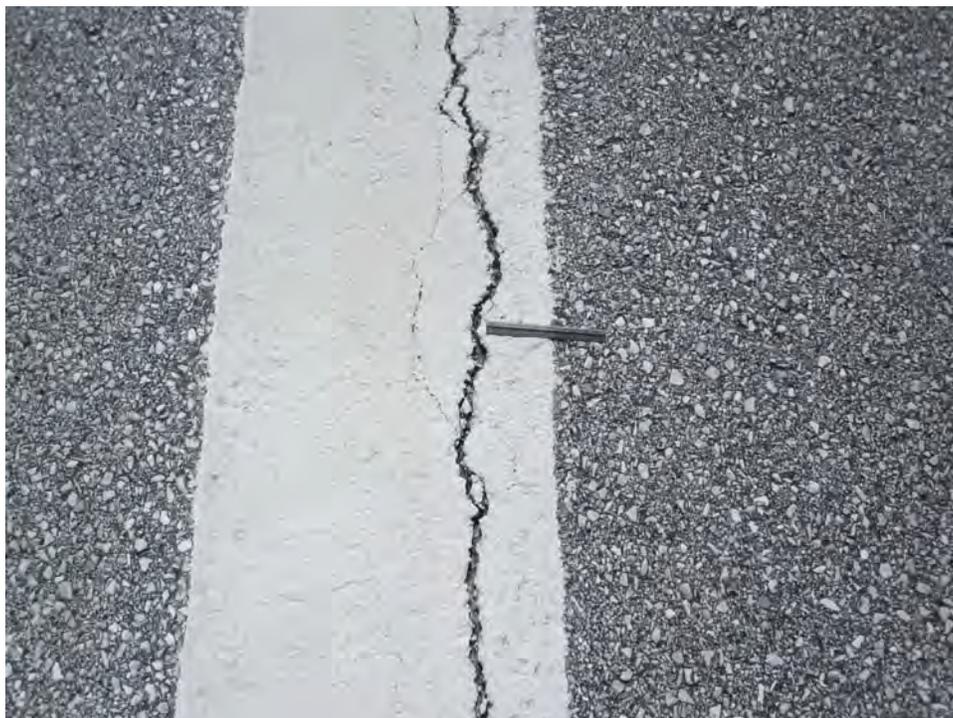
RW1331RT-30. Longitudinal and transverse cracking.

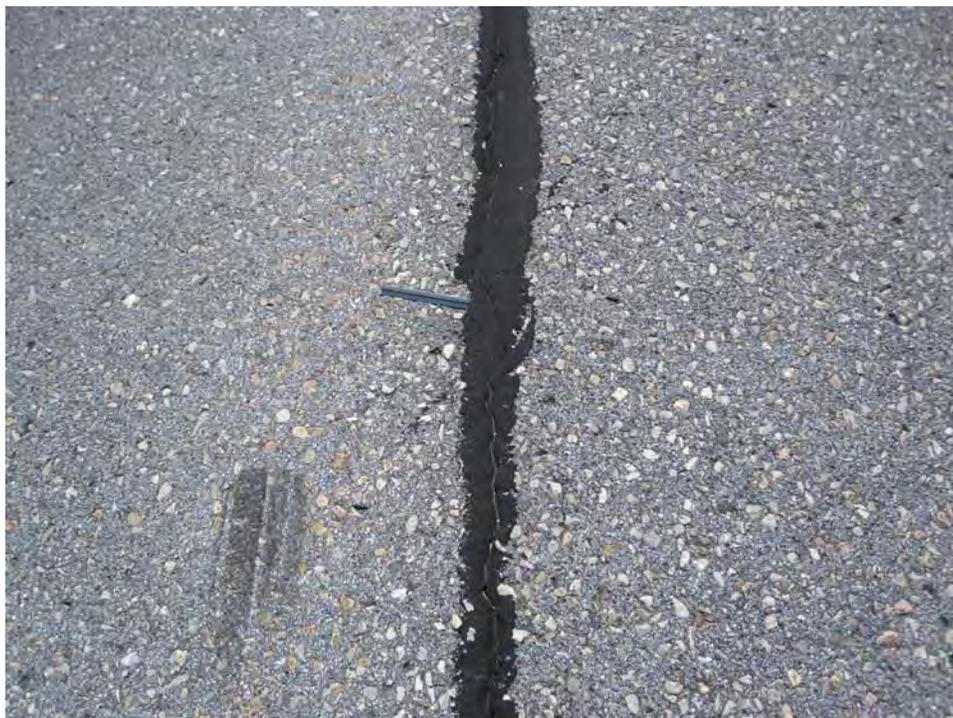
RW1331RT-40. Longitudinal and transverse cracking.

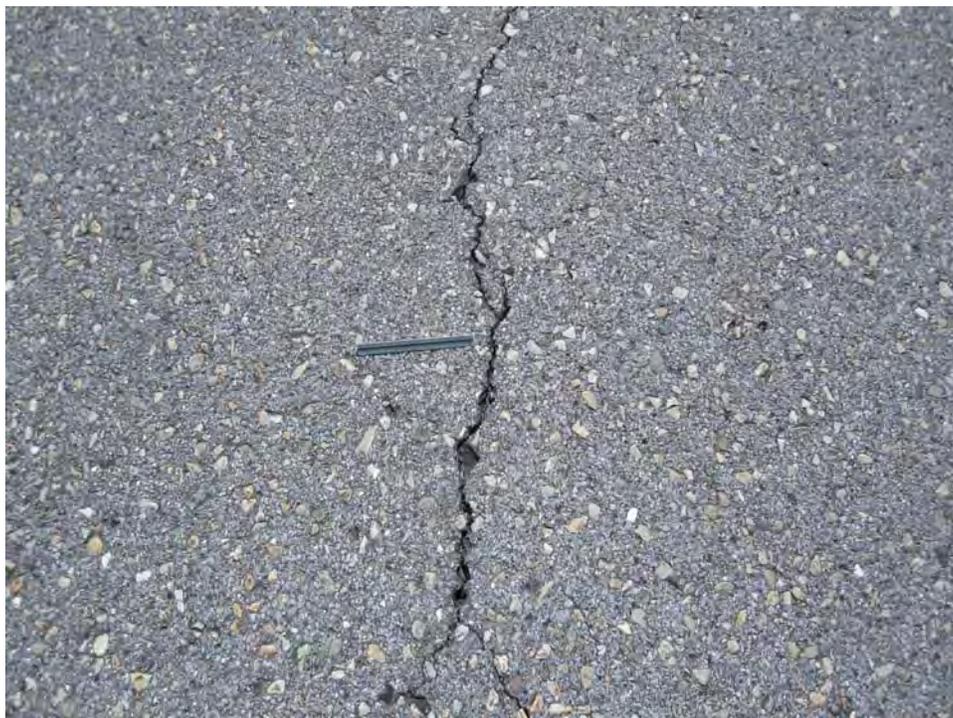
RW1331RT-50. Longitudinal and transverse cracking.

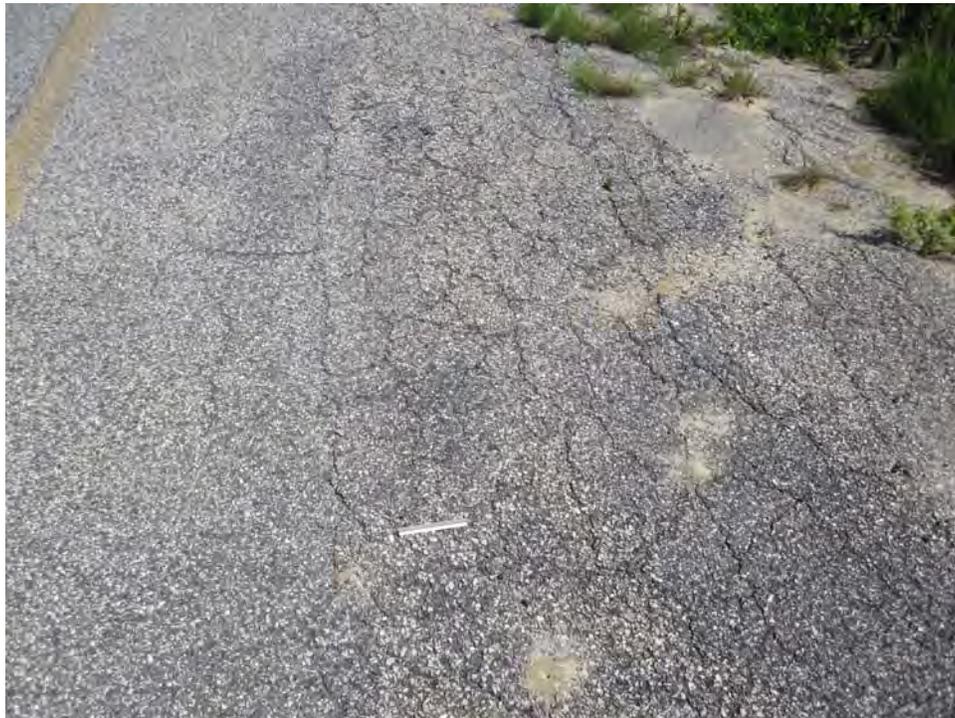
A01RT-30. Alligator cracking.
