RESEARCH UPDATE

U2015-01

### Assessment of the Composite Arch Bridge System (Bridge in a Backpack) First Year Findings

#### References – Work Plan No. 2013-PIF-01

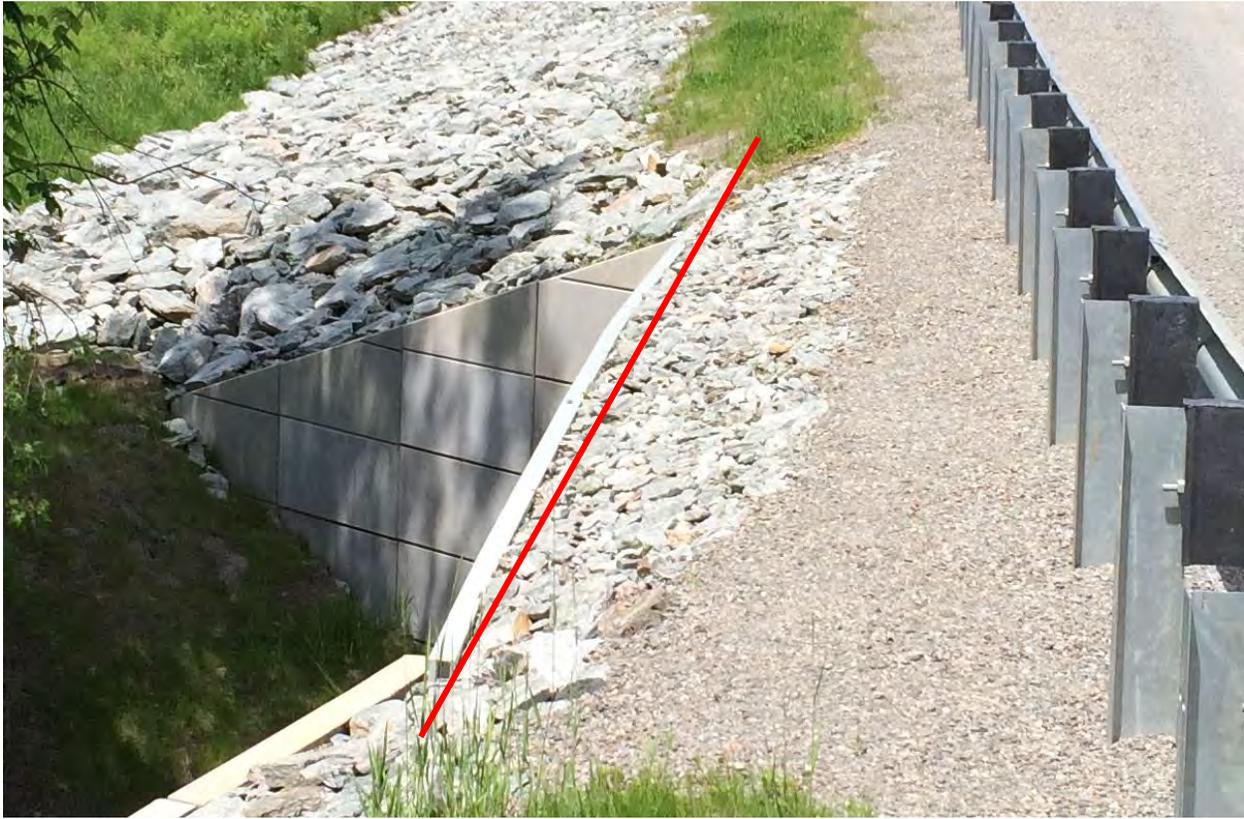
Initially, the overall appearance and basic geometry of the bridge was evaluated. Since the last site visit a year ago, the overall appearance has not changed. No points of impacts or damage were observed. The riverbed under the bridge appeared to have experienced very little change since construction. Overall, the bridge appeared to be performing as expected. One area of concern is that the headwalls seem to be bowing outward by the lateral pressures applied to them by the roadway bed. The bowing appears to be in 1-3 inch range at this point and will need to be monitored more closely in subsequent site visits. The westerly headwall is bowing throughout its entire length in a smooth curve, where the easterly headwall seems to be held back in some places, and bowing in others with a meandering curved shape (see Figure 1 and Figure 2).

**Figure 1 Westerly headwall with bowing out with a smooth curved shape**

There appears to be no change to the overall shape and performance of the externally FRP reinforced concrete arches. The arches are not exhibiting any negative environmental impacts. There is no impact damage to the arches from stream activity. The headwalls are showing some displacement, which may be due to setting of materials. Continued monitoring including a

method of measurement for the headwalls is appropriate. An inlet and outlet arch will be added to the dimensional checks in subsequent years. Notification of the change in condition will be provided to VTrans Structures, District and Geotechnical staff for their consideration.

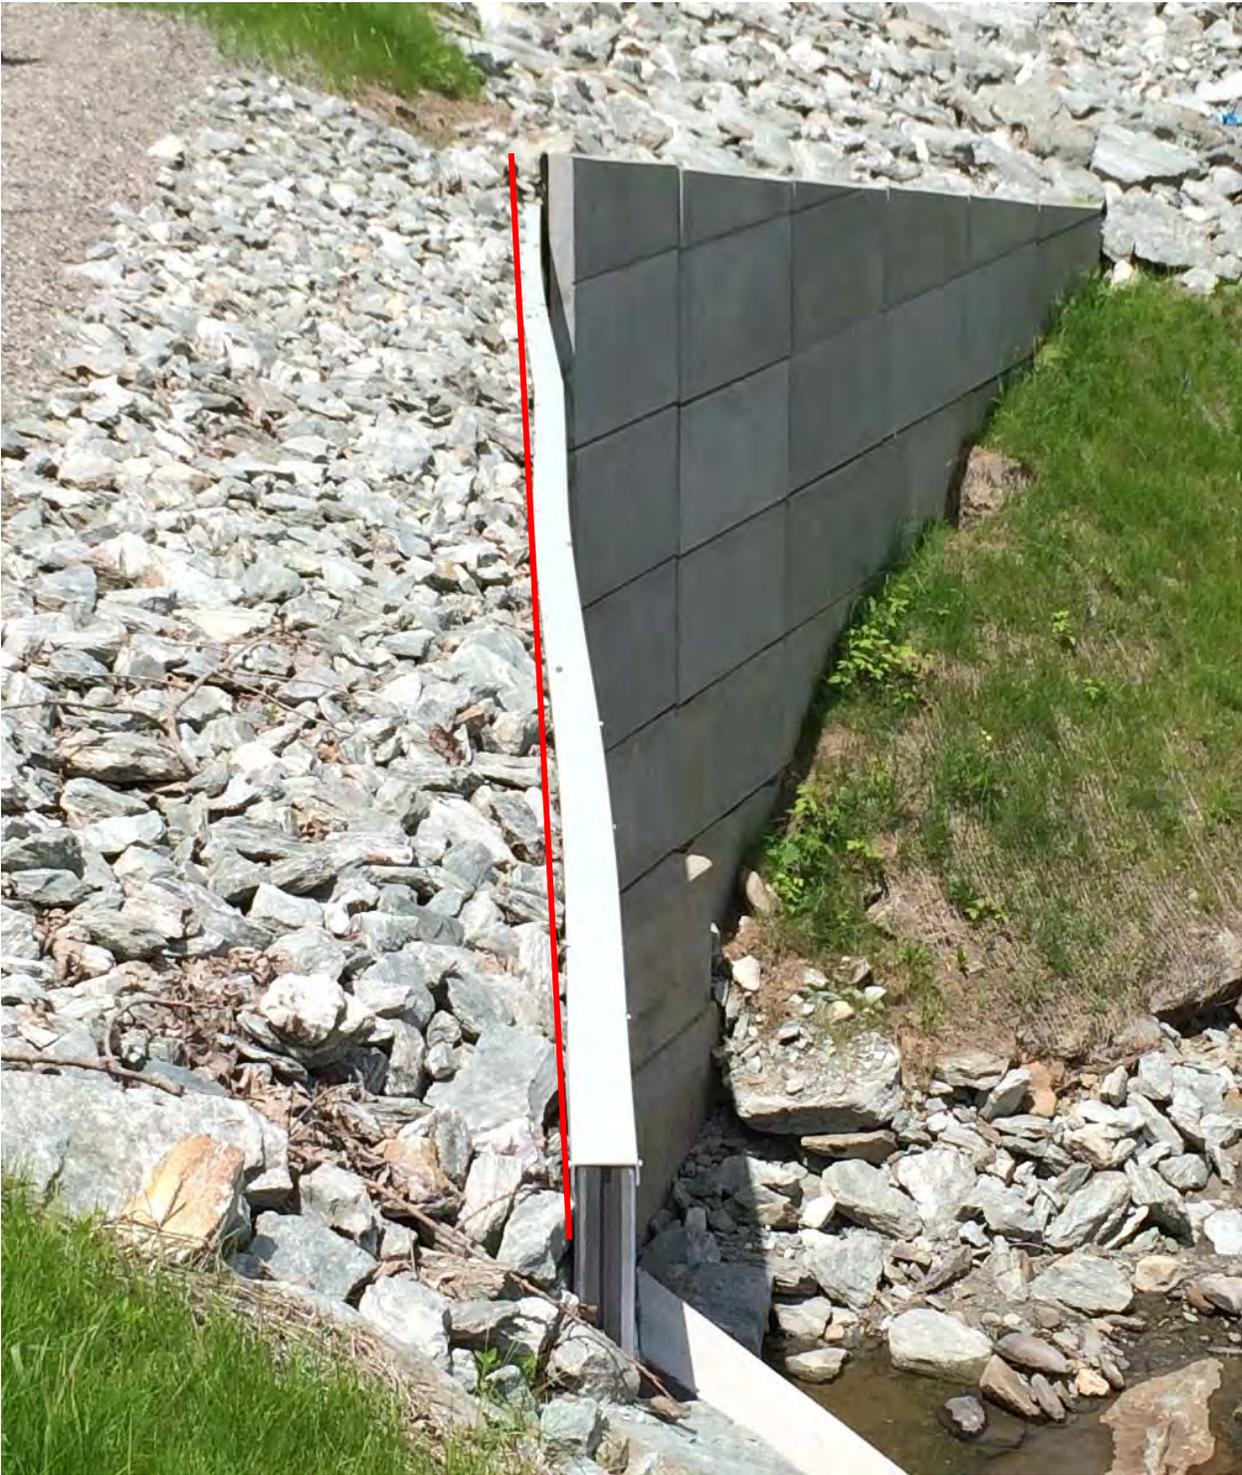
**Figure 2 Easterly headwall bowing out with a meandering curved shape**

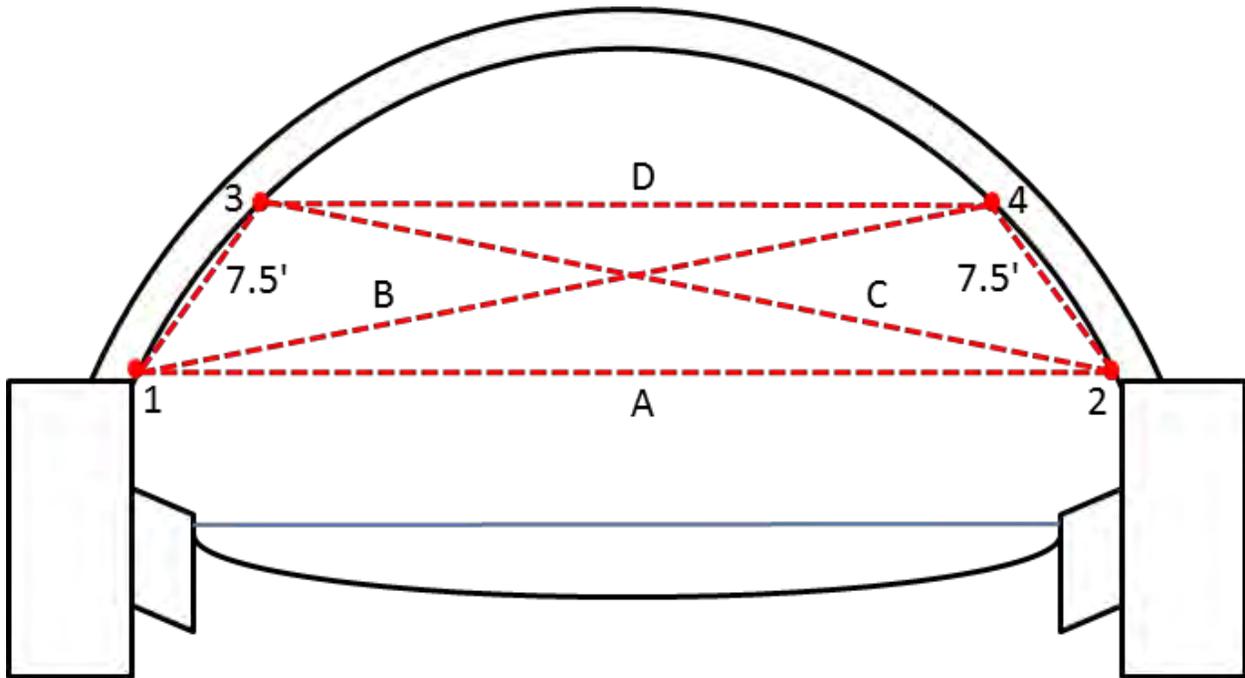
The overall measurements (see Table 1) averaged about 3/8 inch different from the measurements taken in 2014 discounting the sign of the dimensional change. If expansion and contraction is considered the average change is 3/16 of an inch. These represented a 1.38% and 0.68 % overall difference respectively. The differences did not indicate any significant change is occurring. One of the diagonal measurements displayed a contraction on all three arches of approximately 3/4 of inch, which is well within the capacity of the arches to redistribute loads without harm.

The data collected over the last year suggests that there is contraction occurring in the horizontal line 'A' for arch 6 of about 1/4 inch, and an expansion of about a 1/4 inch for arch 4 and 3/8 inch for arch 5. All arches showed expansion along the diagonal line 'B' from 5/8 inch on arch 4 down to an 1/8 inch on arch 6. All arches showed contraction along the diagonal line C from 3/4 inch on arch 4 to 7/8 inch on arch 6. Arch 4 showed some expansion by 1/8 inch along

horizontal line 'D' where arches 5 and 6 showed contraction by 3/8 inch. These measurements suggest that the arches are deflecting slightly in a southerly direction.

Figure 3 Measurements taken
