MIDDLEBURY STATE AIRPORT PHOTOS

MORRISVILLE – STOWE STATE AIRPORT PHOTOS

NEWPORT STATE AIRPORT PHOTOS

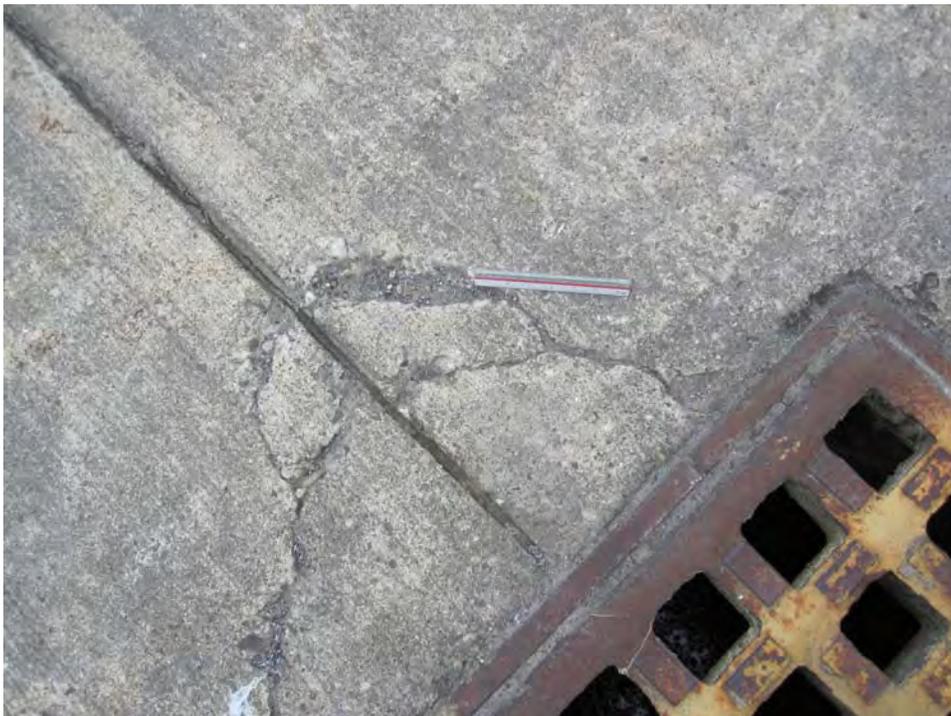
A02MB-20. Corner spall.

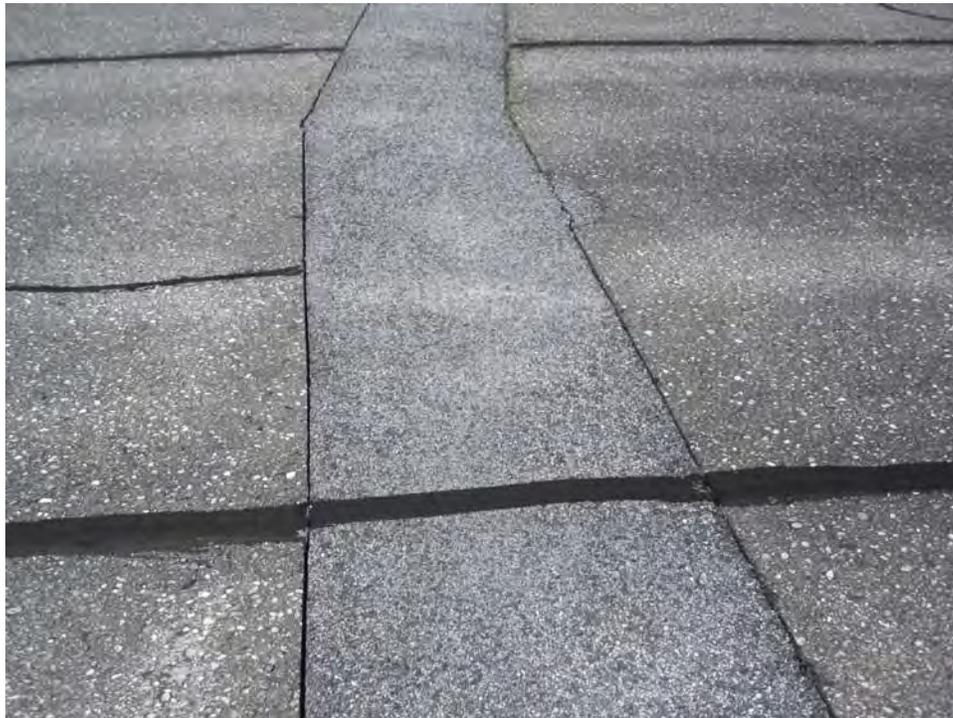
RW119MV-10. Patching (2).

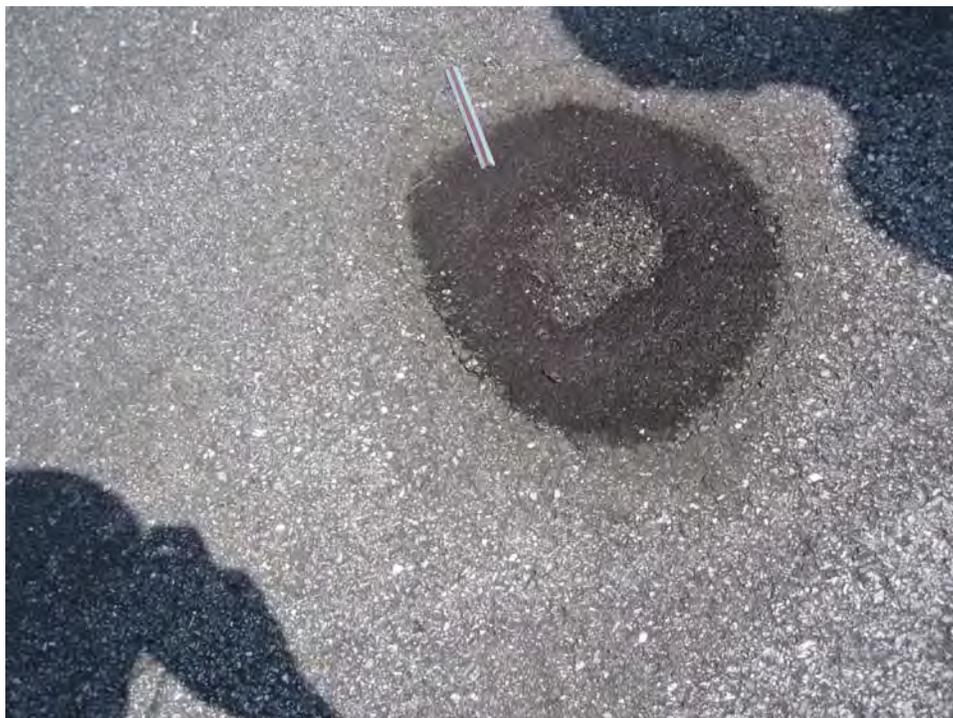
RW1836NP-20. Depression.

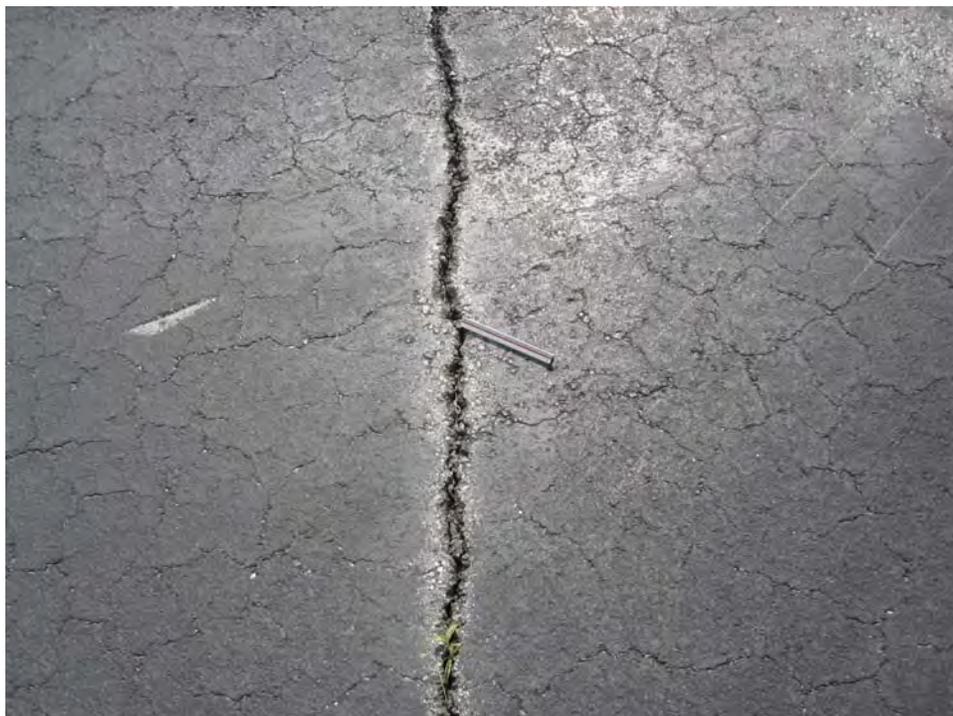
A01NP-30. Longitudinal and transverse cracking.

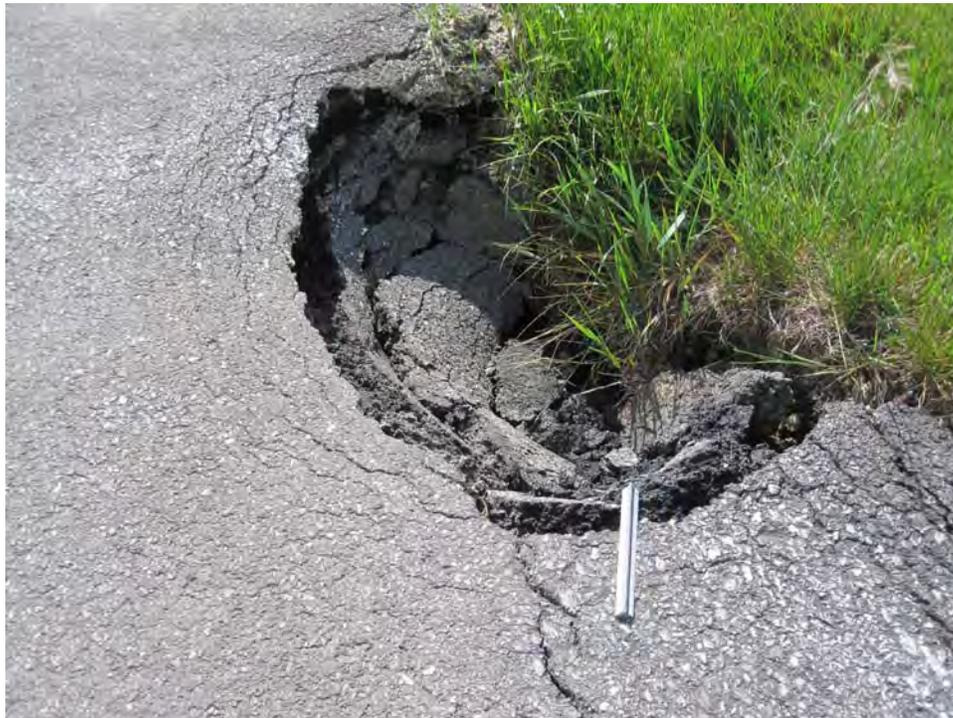
A01NP-60. Depression.

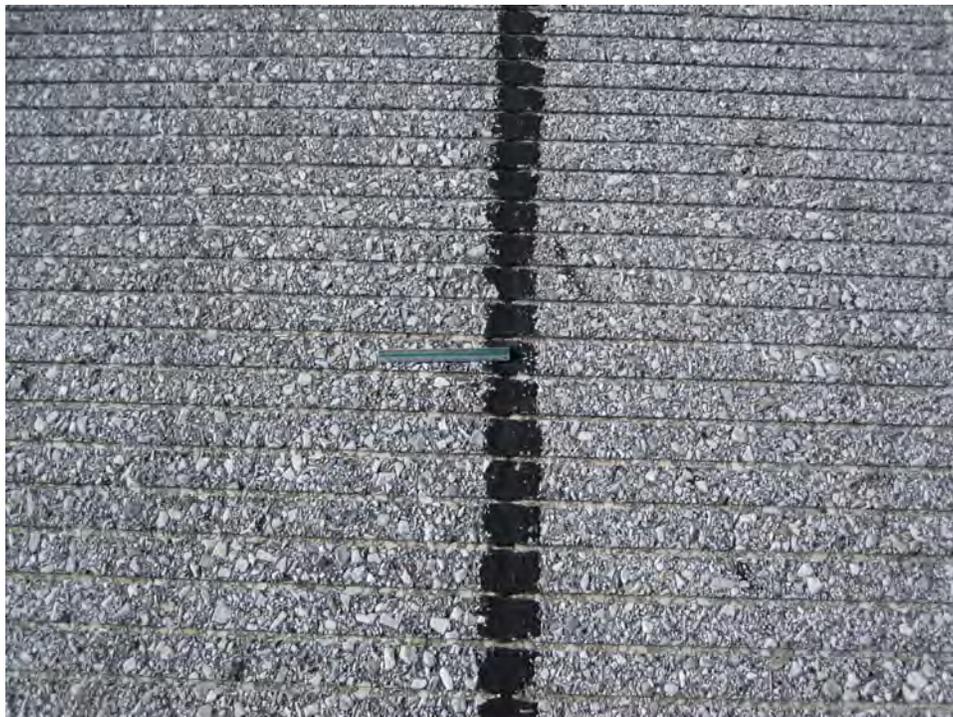
RW119RT-10. Longitudinal and transverse cracking.

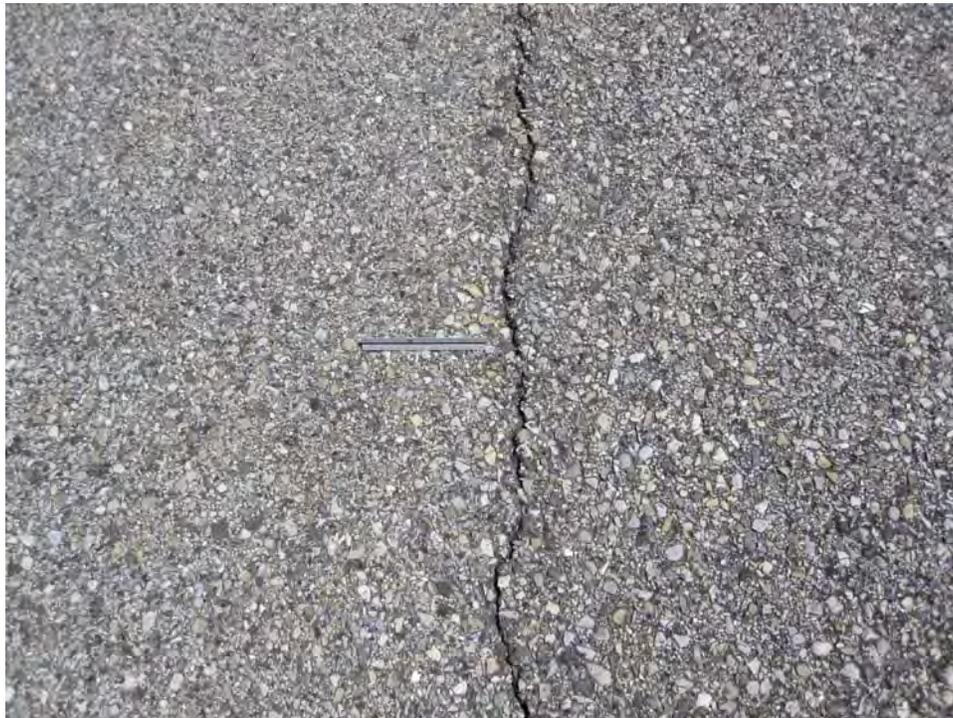
TWBRT-10. Longitudinal and transverse cracking.

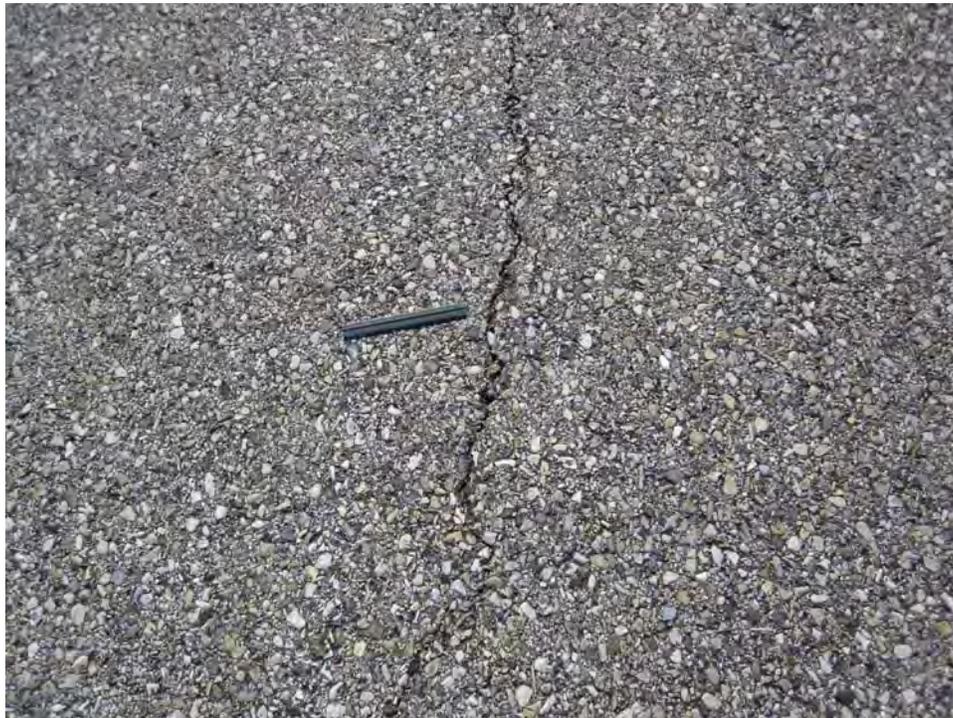
TWBRT-20. Longitudinal and transverse cracking.

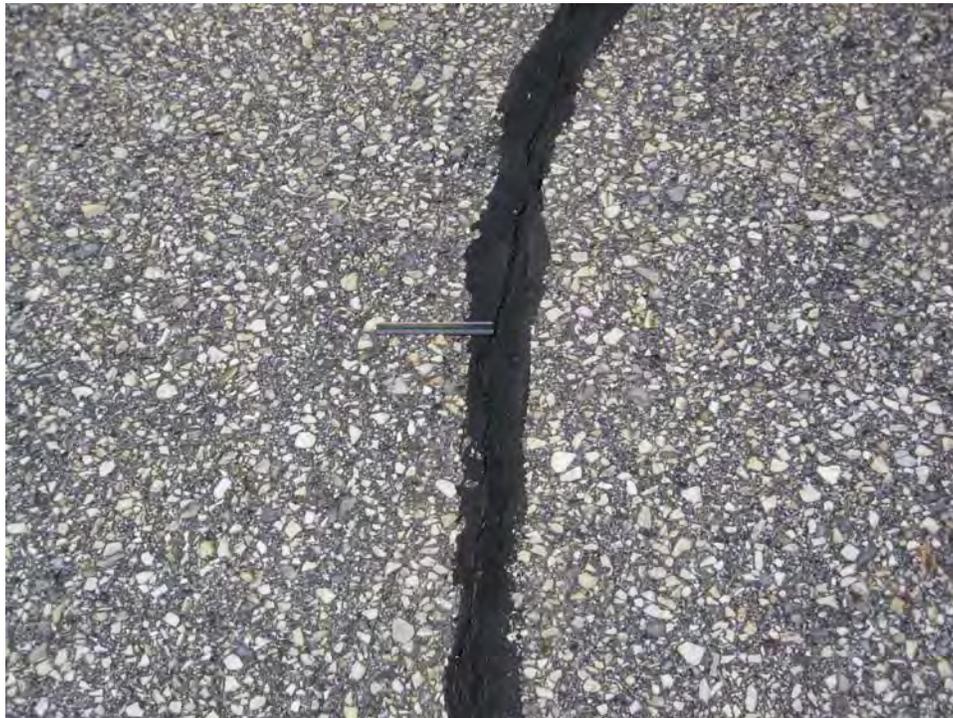
TWCRT-10. Longitudinal and transverse cracking.

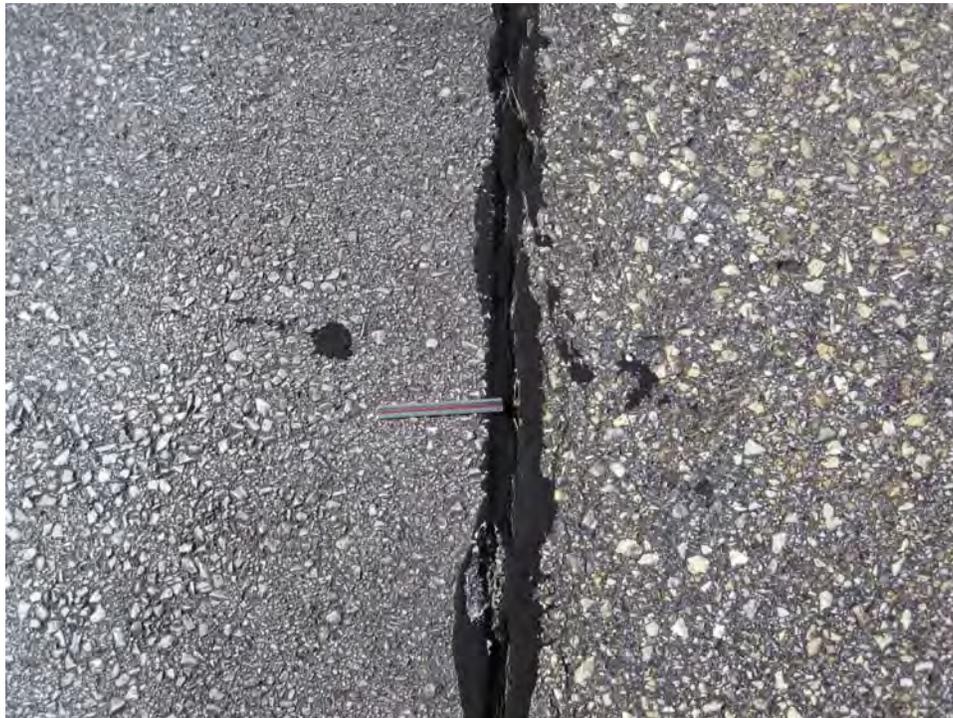
TWDRT-10. Longitudinal and transverse cracking.

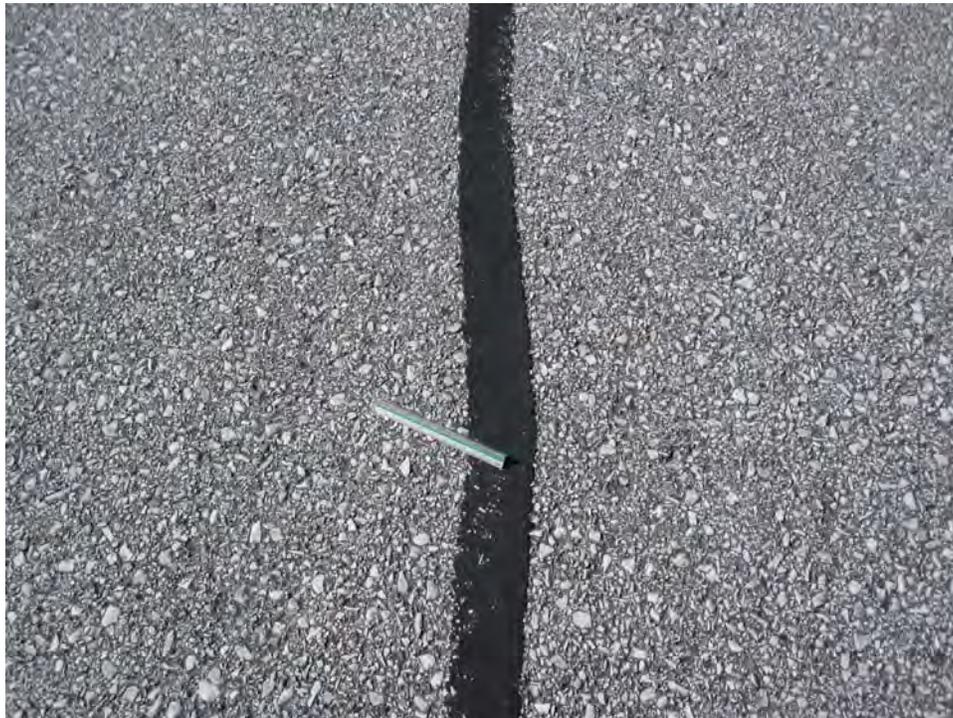
TWDRT-20. Longitudinal and transverse cracking.

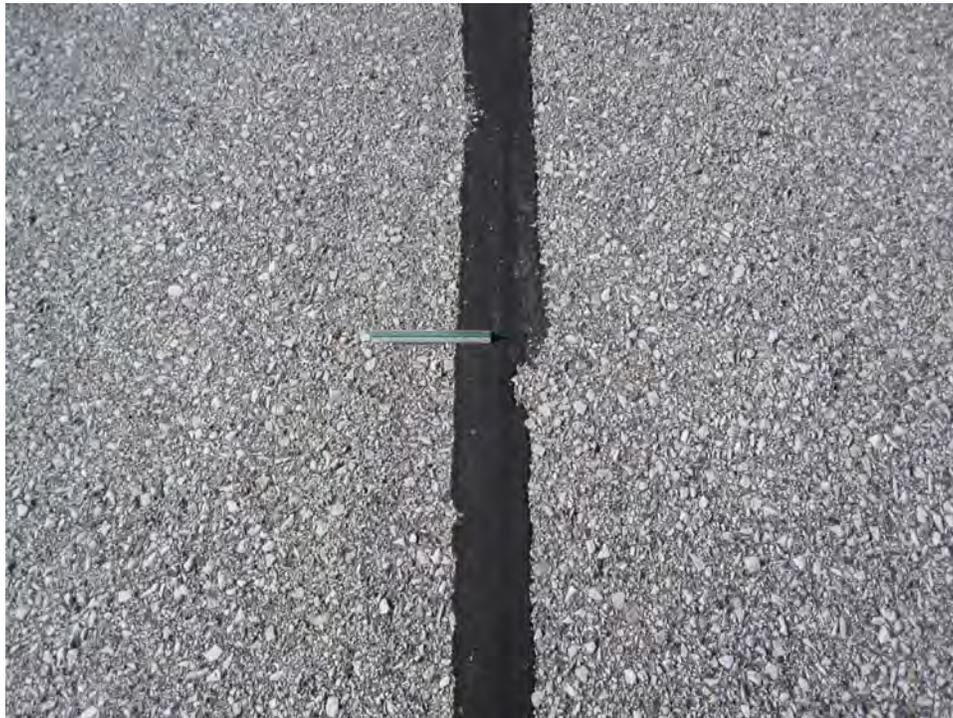
TWERT-10. Longitudinal and transverse cracking.

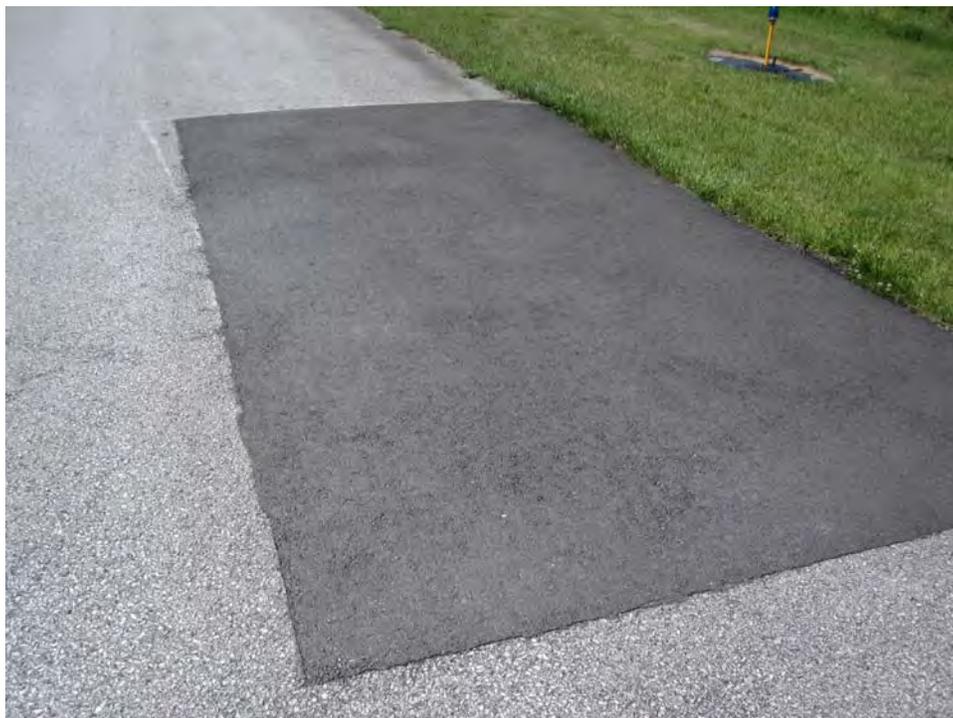
TWFR-10. Patching.

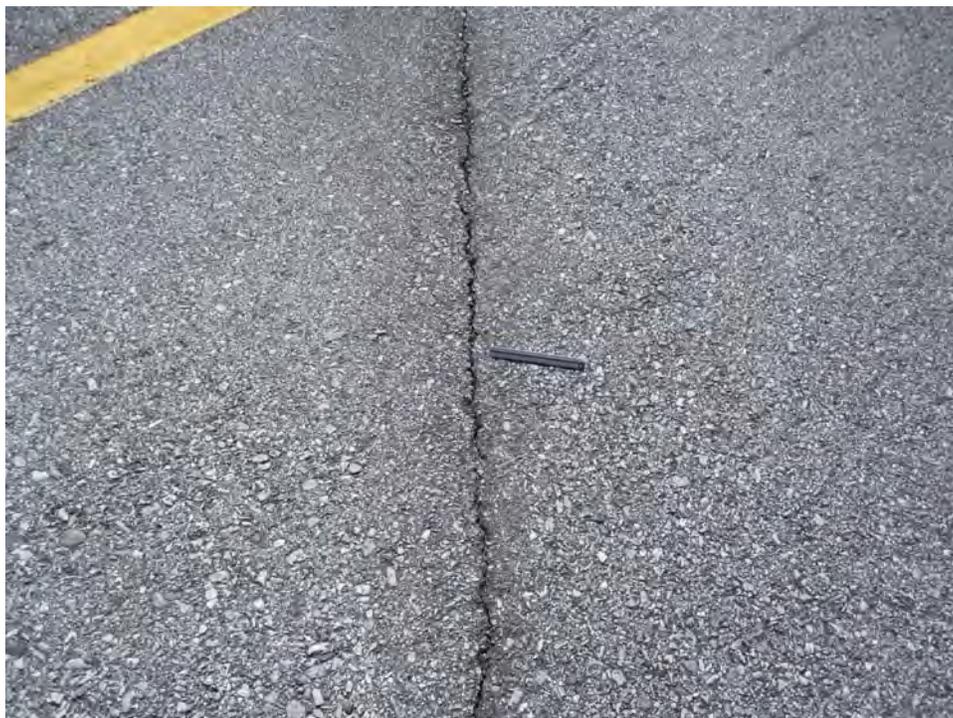
TWGRT-10. Longitudinal and transverse cracking.

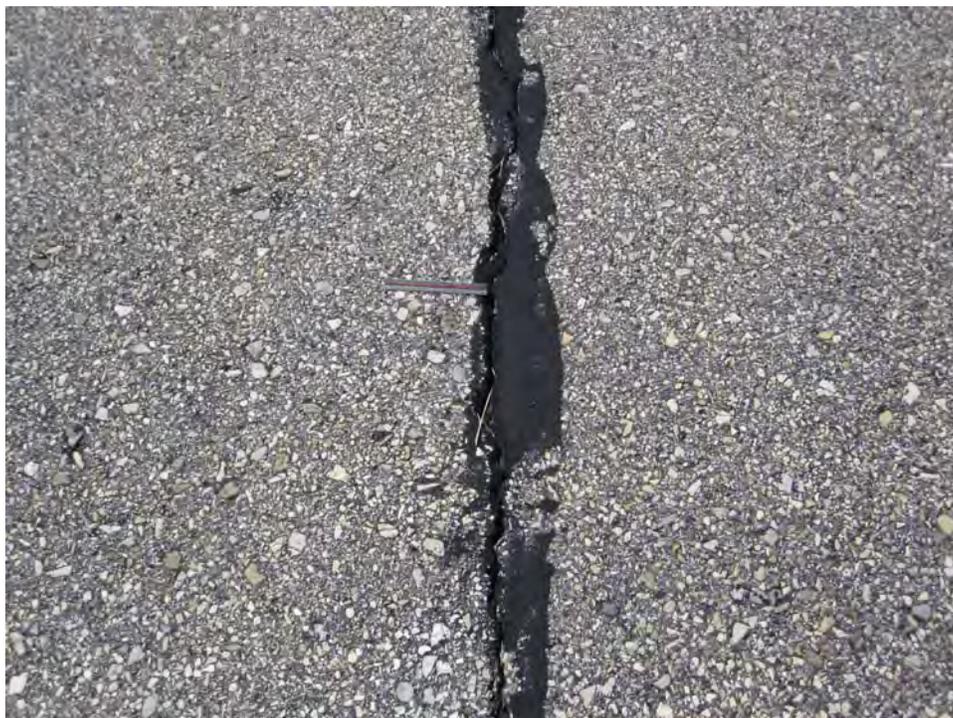
A01RT-10. Longitudinal and transverse cracking.

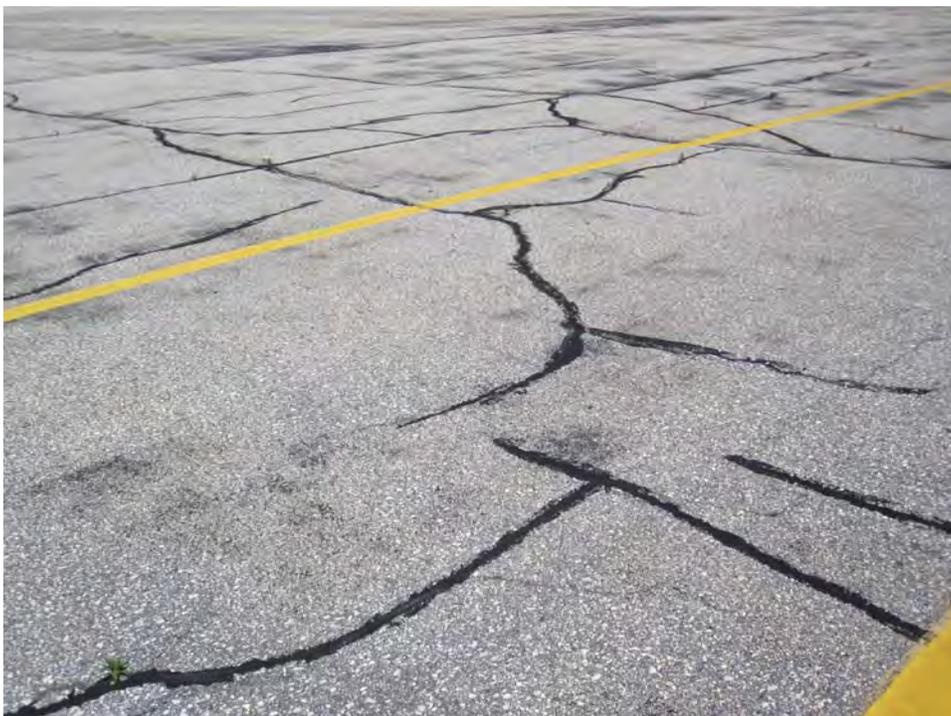
A01RT-20. Block cracking.

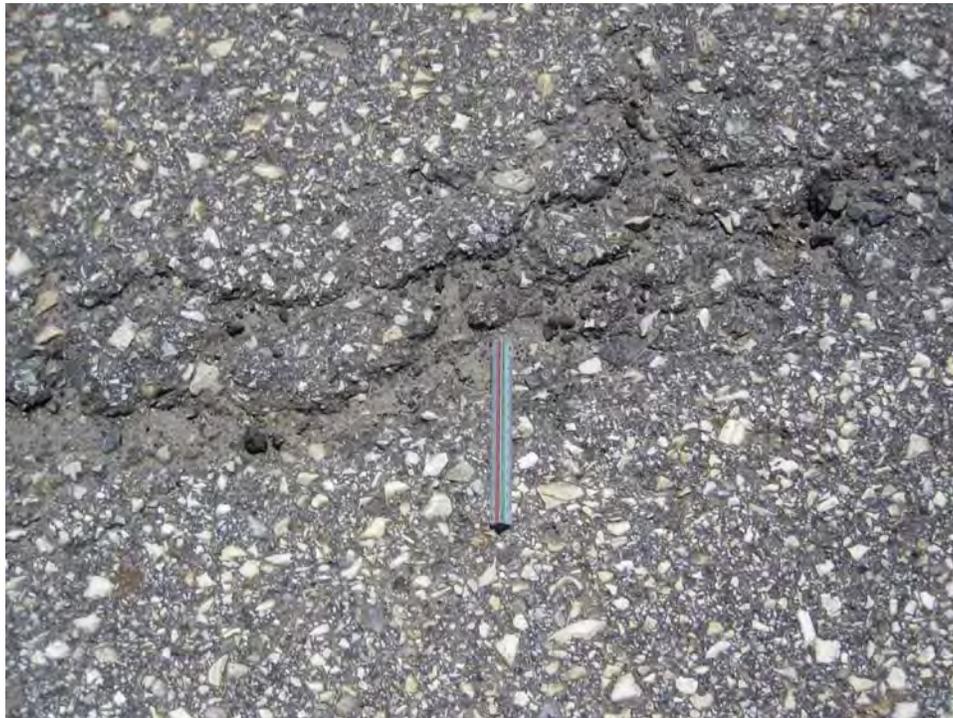
A01RT-20. Raveling.

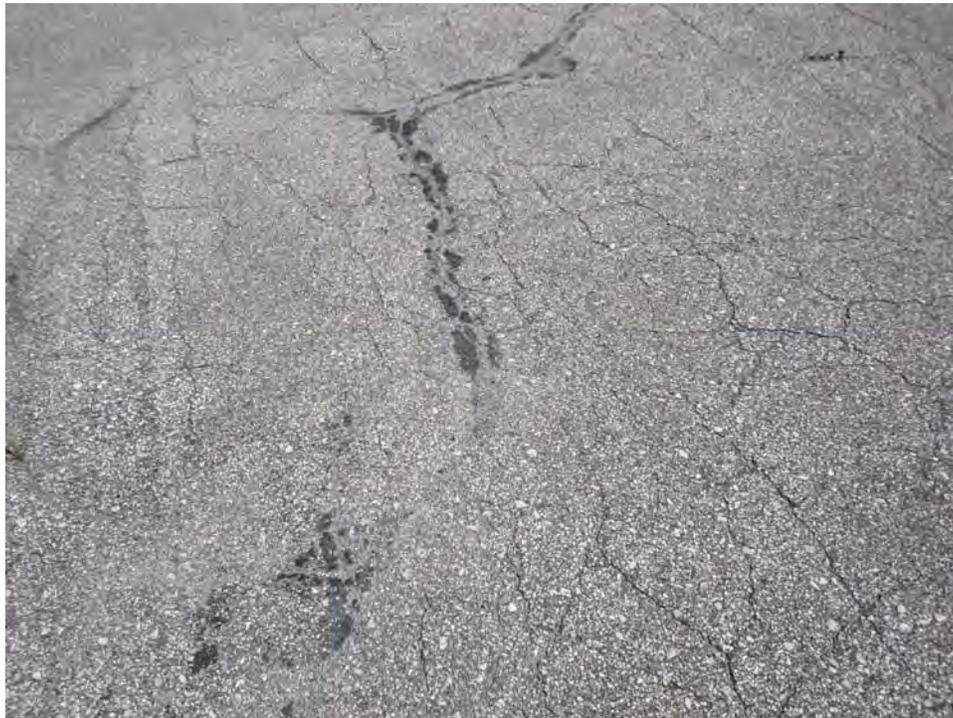
A01RT-40. Alligator cracking.

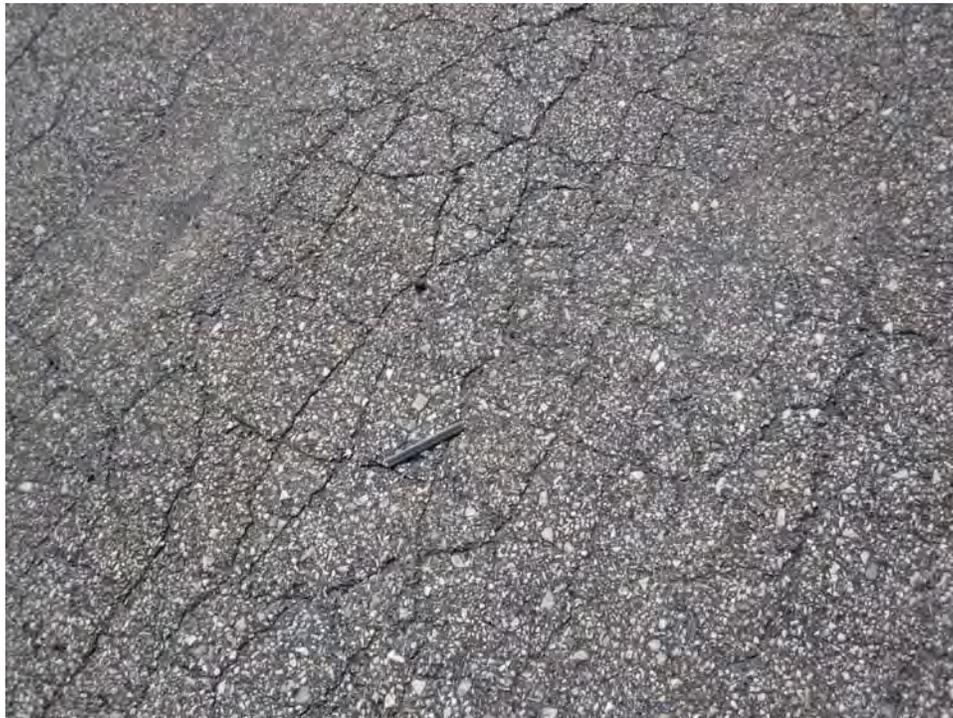
A01RT-50. Alligator cracking.

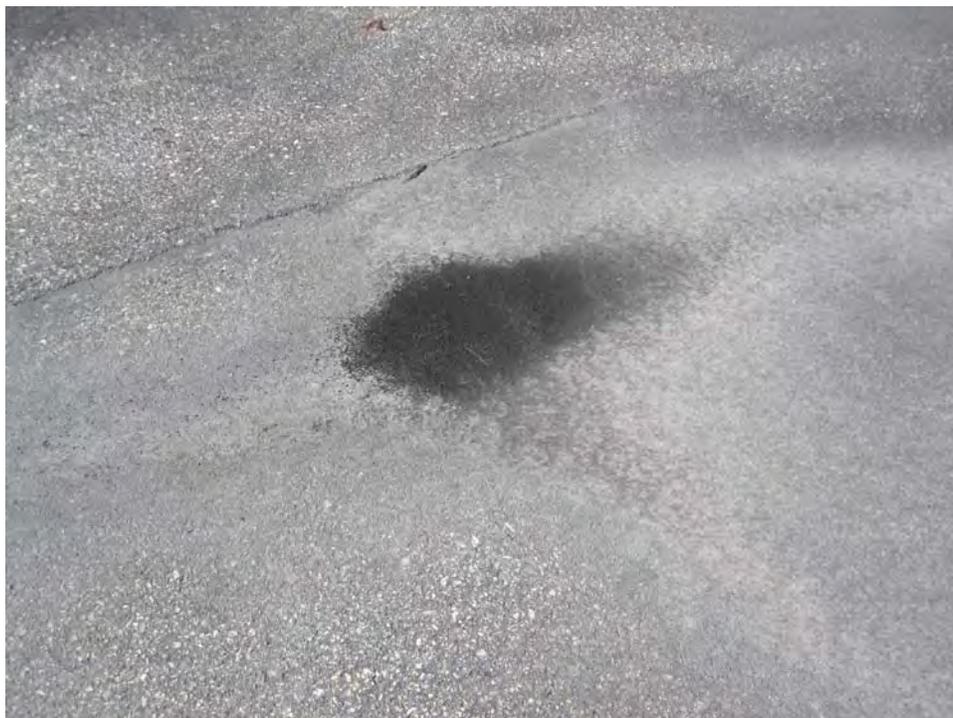
A02RT-10. Depression.

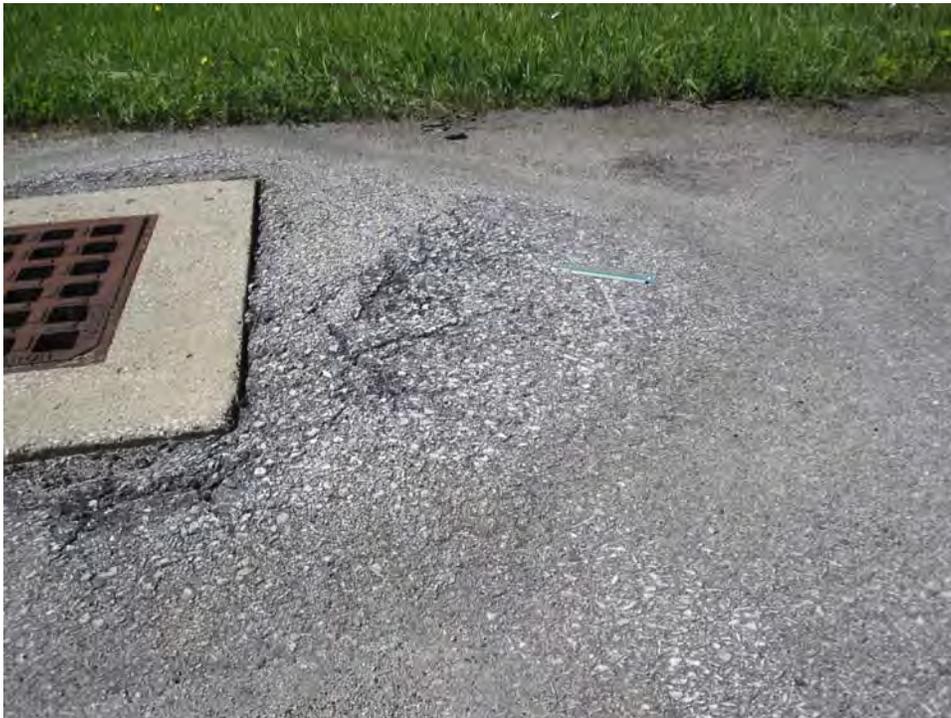
A03RT-10. Swelling.

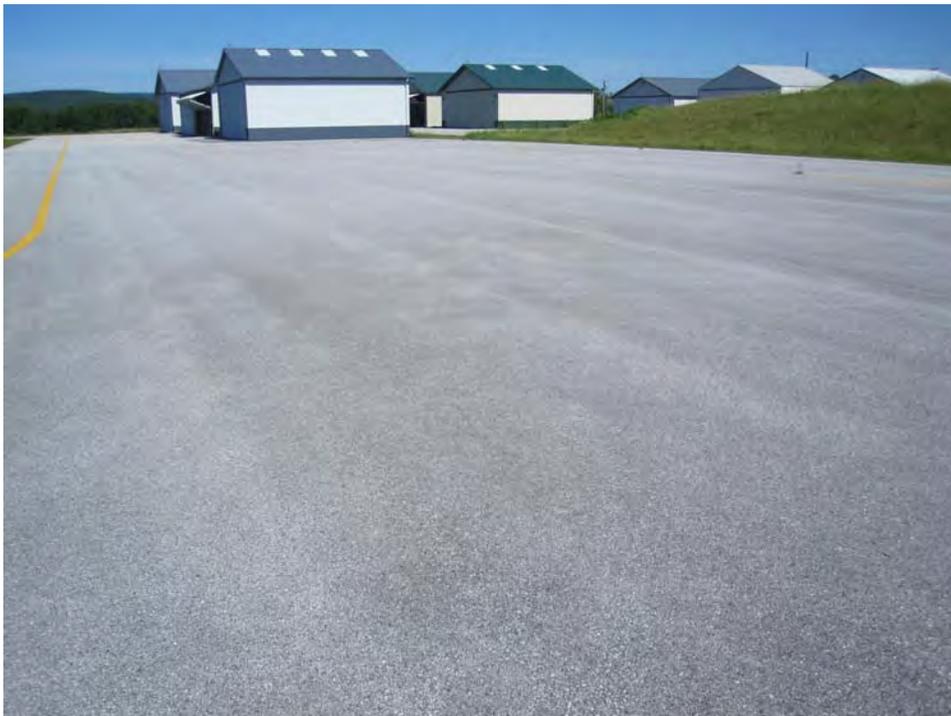
A03RT-20. Overview.

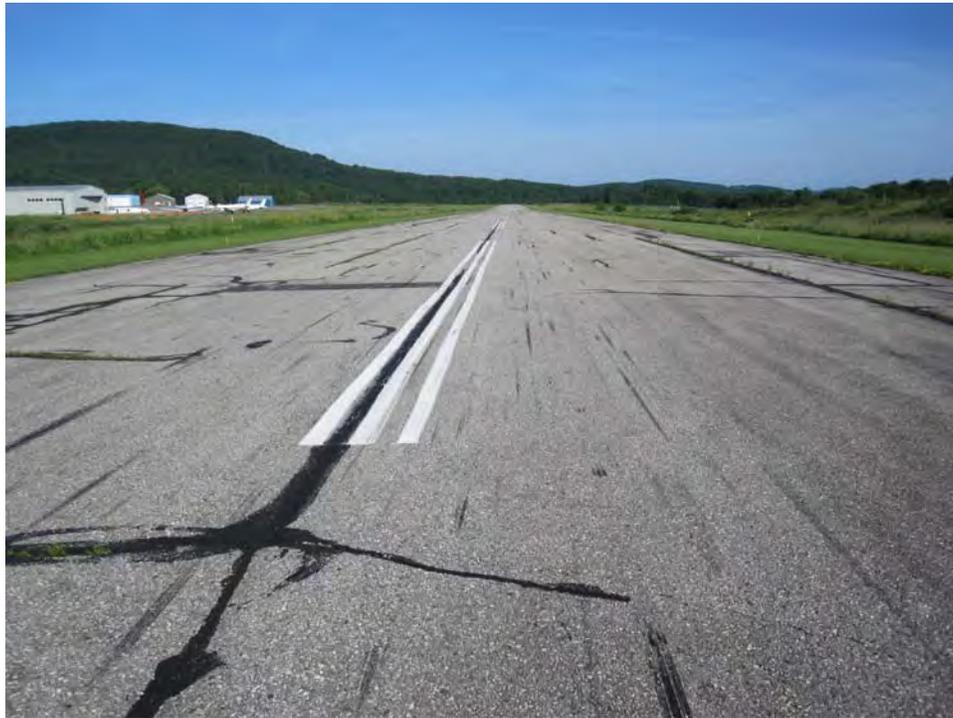
RW1331BN-10. Overview.

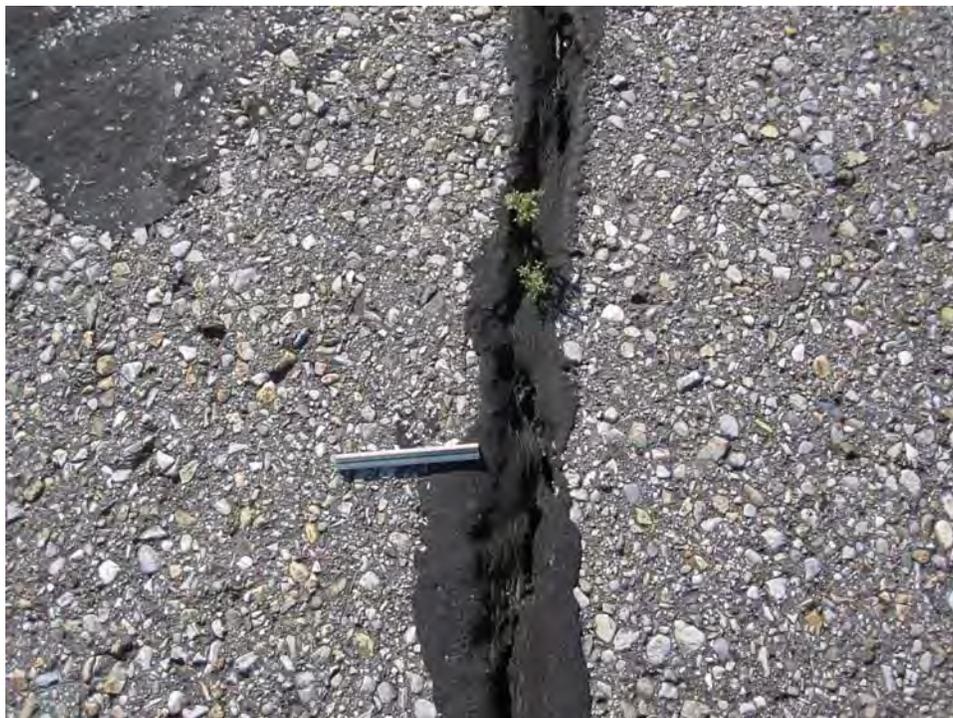
RW1331BN-10. Longitudinal and transverse cracking (1).

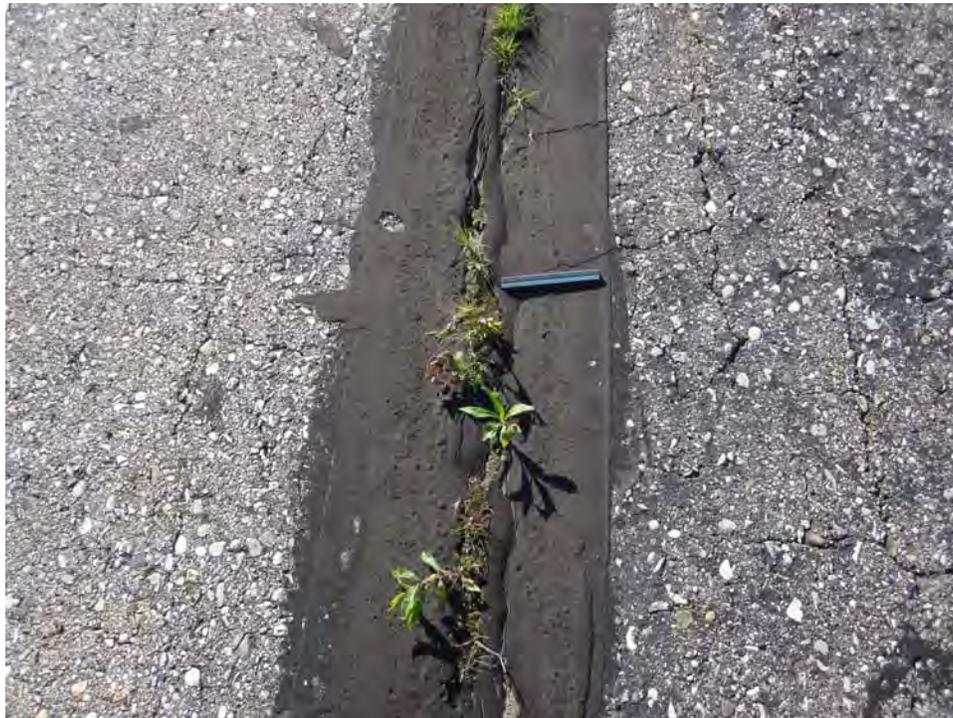
RW1331BN-10. Longitudinal and transverse cracking (2).

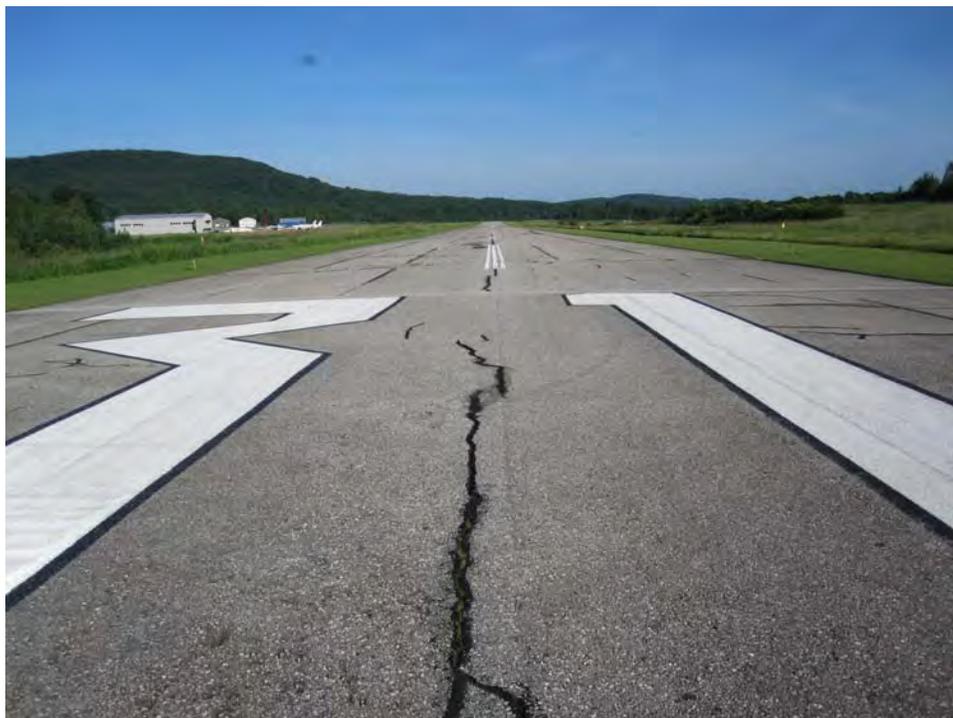
RW1331BN-20. Overview.

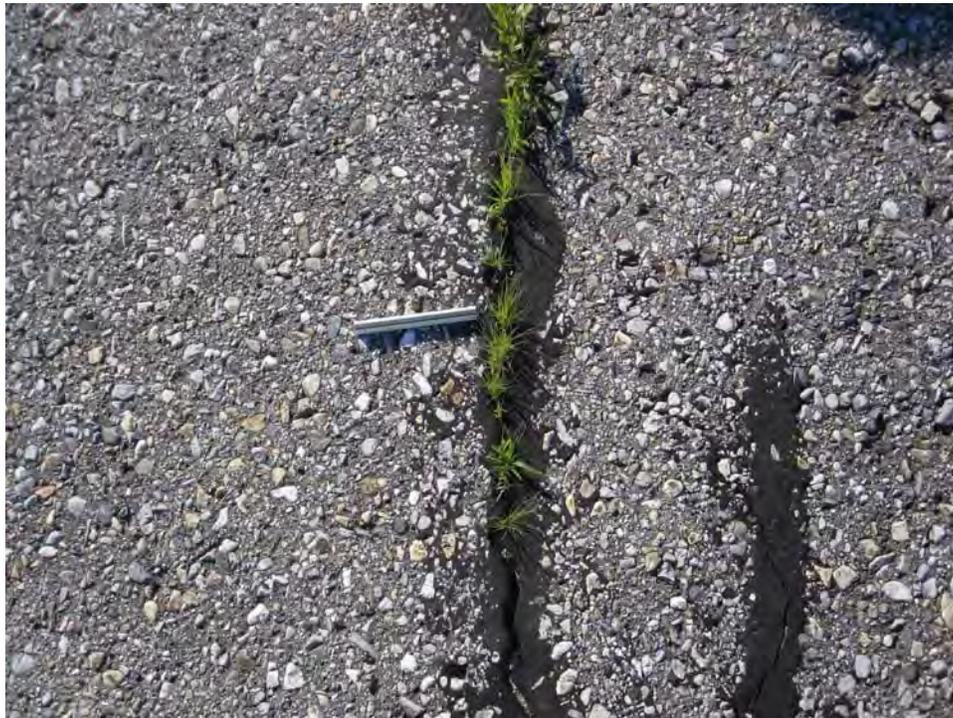
RW1331BN-20. Longitudinal and transverse cracking.

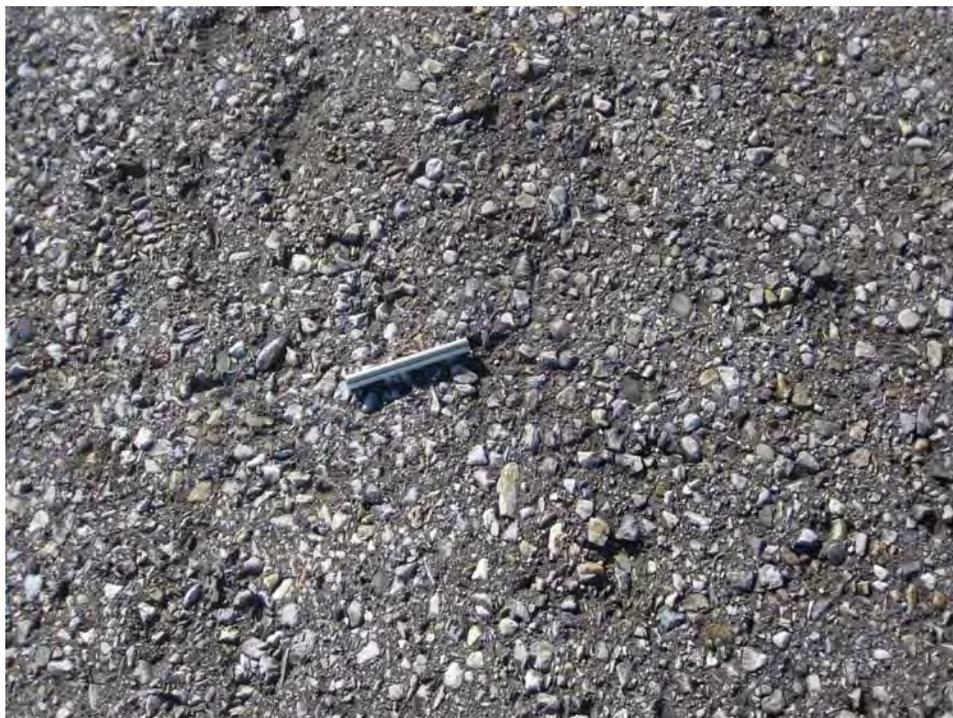
RW1331BN-20. Raveling.

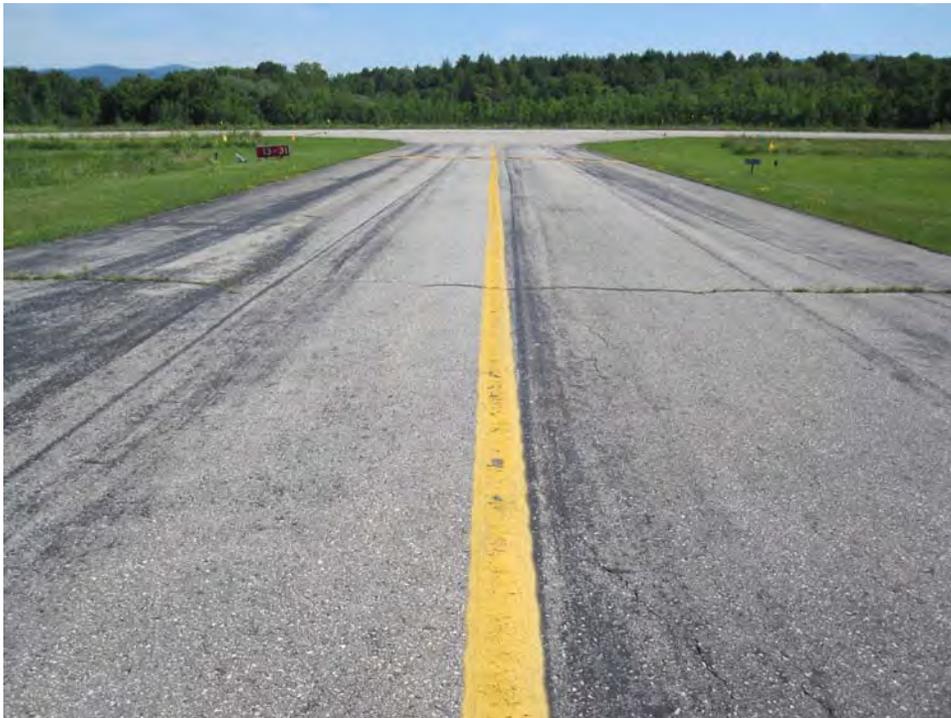
TAABN-10. Overview.

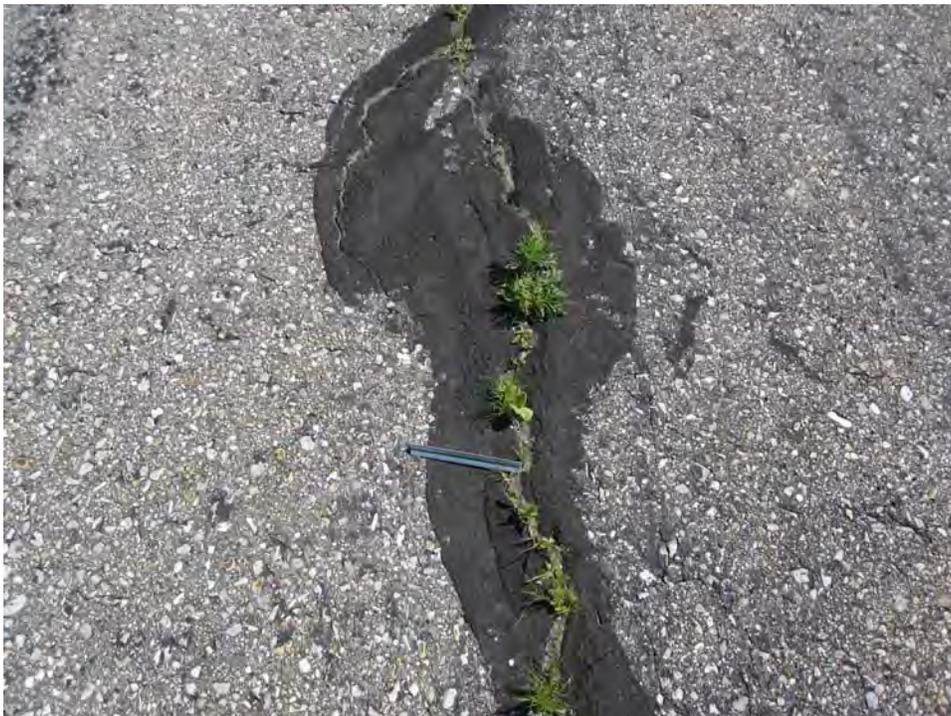
TWABN-10. Longitudinal and transverse cracking.

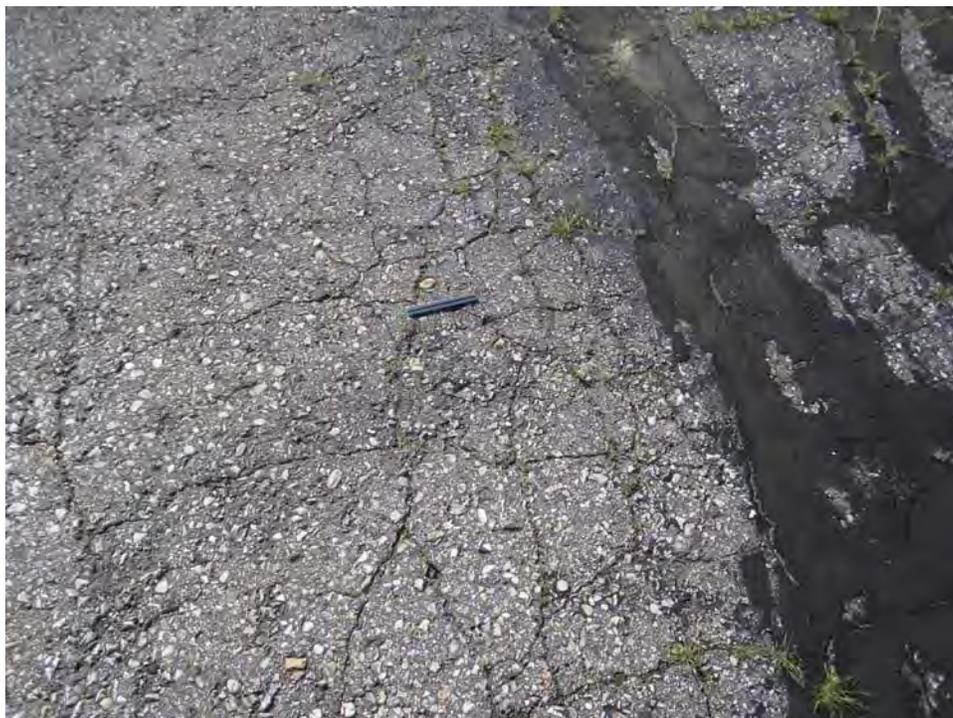
TWBBN-10. Alligator cracking.

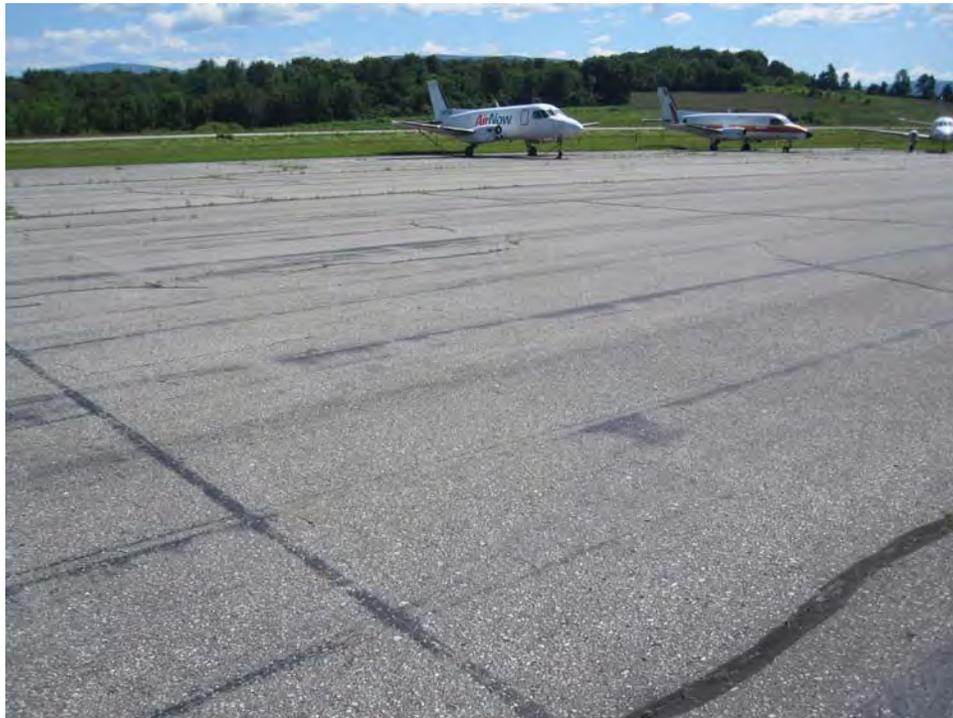
A01BN-10. Overview.

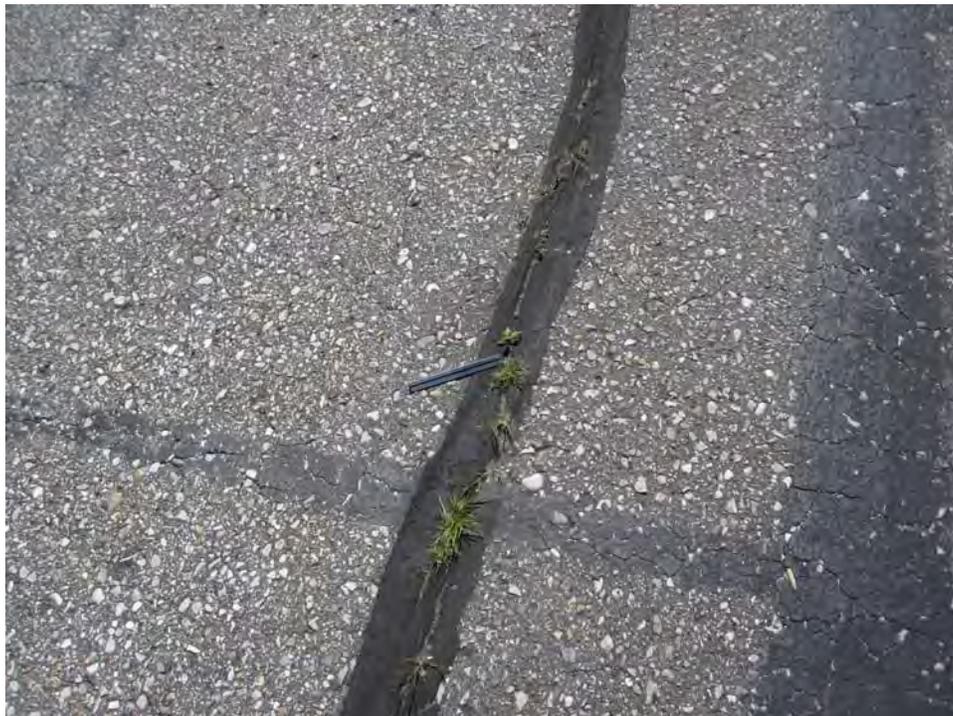
A01BN-10. Longitudinal and transverse cracking.
