MIDDLEBURY STATE AIRPORT PHOTOS

MORRISVILLE – STOWE STATE AIRPORT PHOTOS

NEWPORT STATE AIRPORT PHOTOS

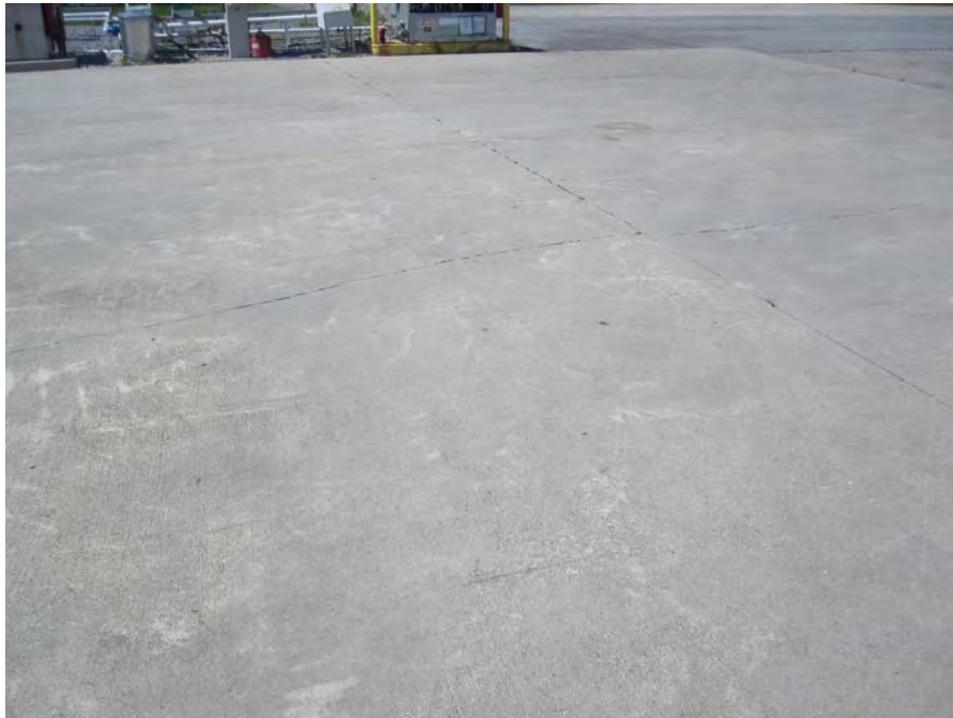
A01BN-20. Overview.

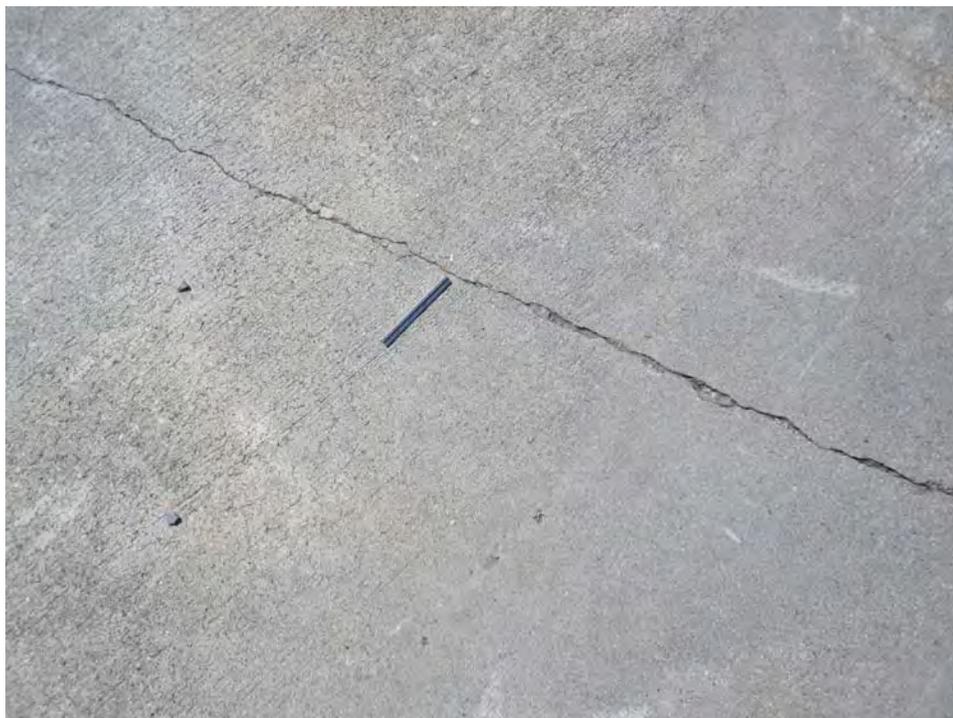
A01BN-20. Longitudinal, transverse and diagonal cracking.

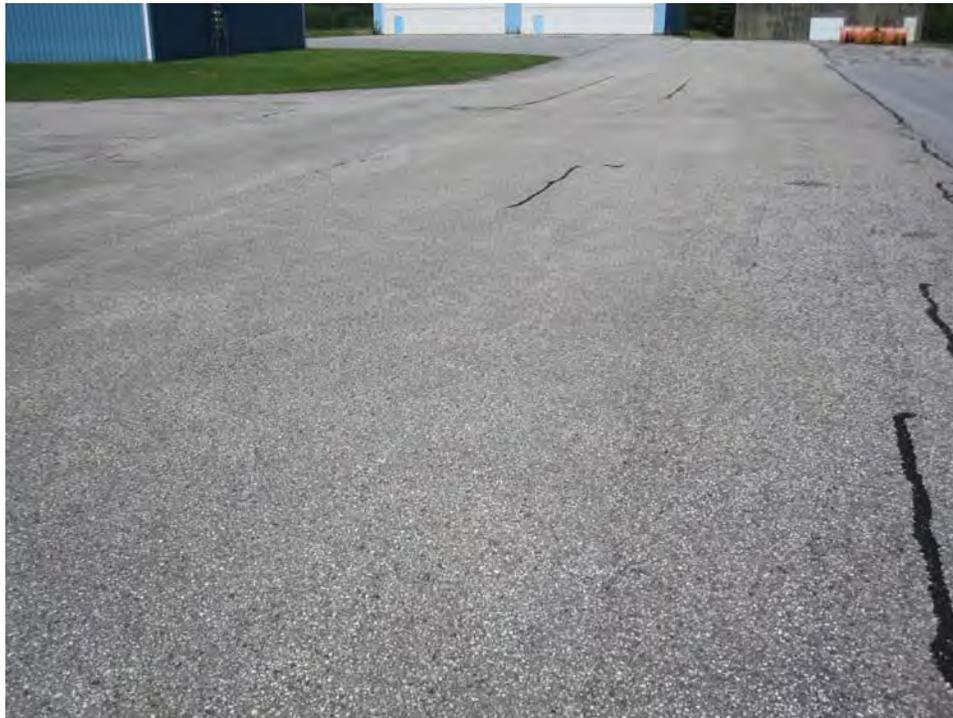
A01BN-30. Overview.

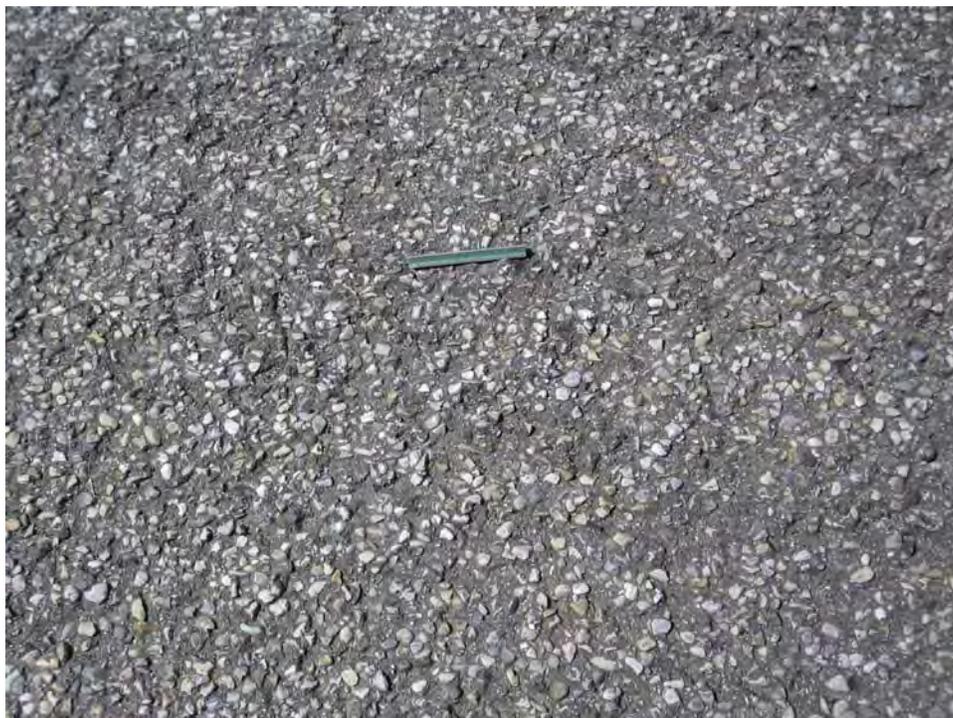
A01BN-30. Raveling.

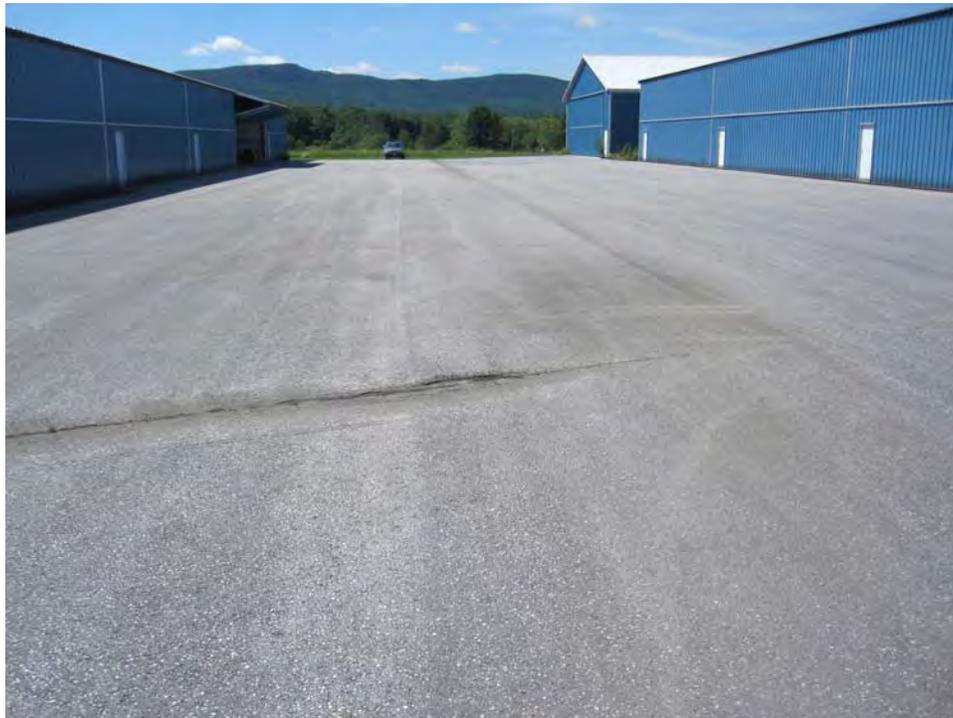
A01BN-40. Overview (1).

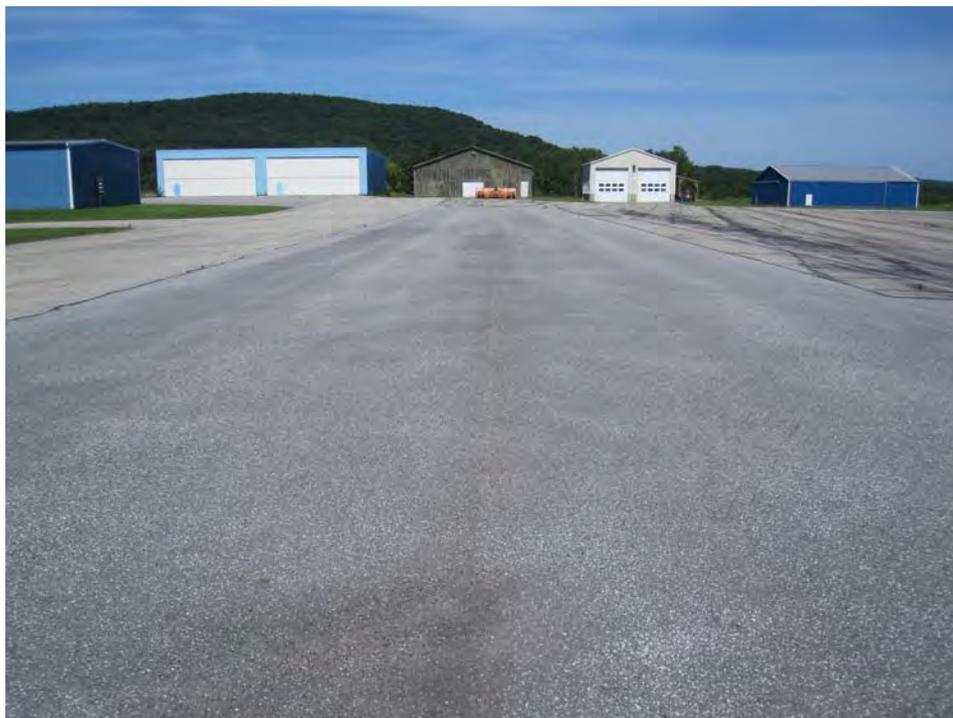
A01BN-40. Overview (2).

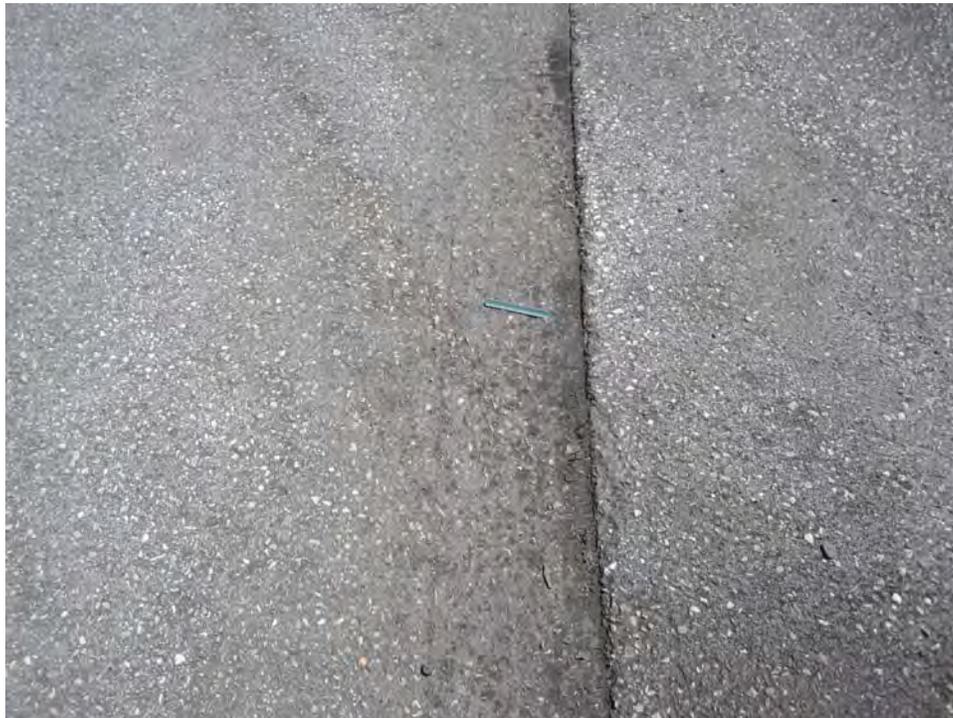
A01BN-40. Raveling (1).

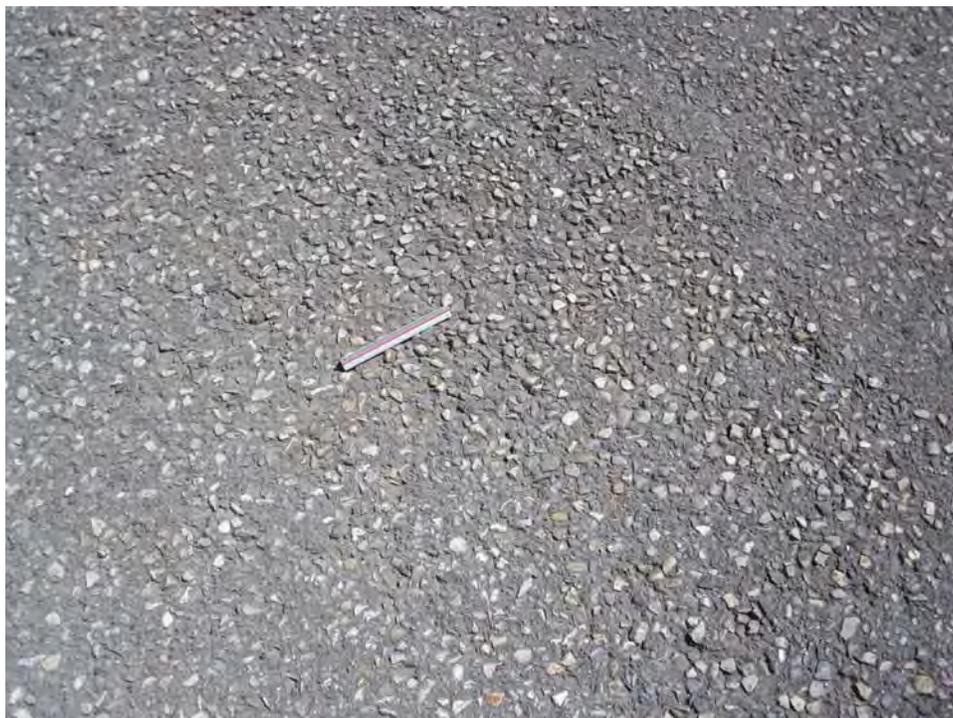
A01BN-40. Raveling (2).
